Appendix D – Crash History Review Technical Memorandum

Project: Southern Meade County Corridor Study

Subject: Crash History Review

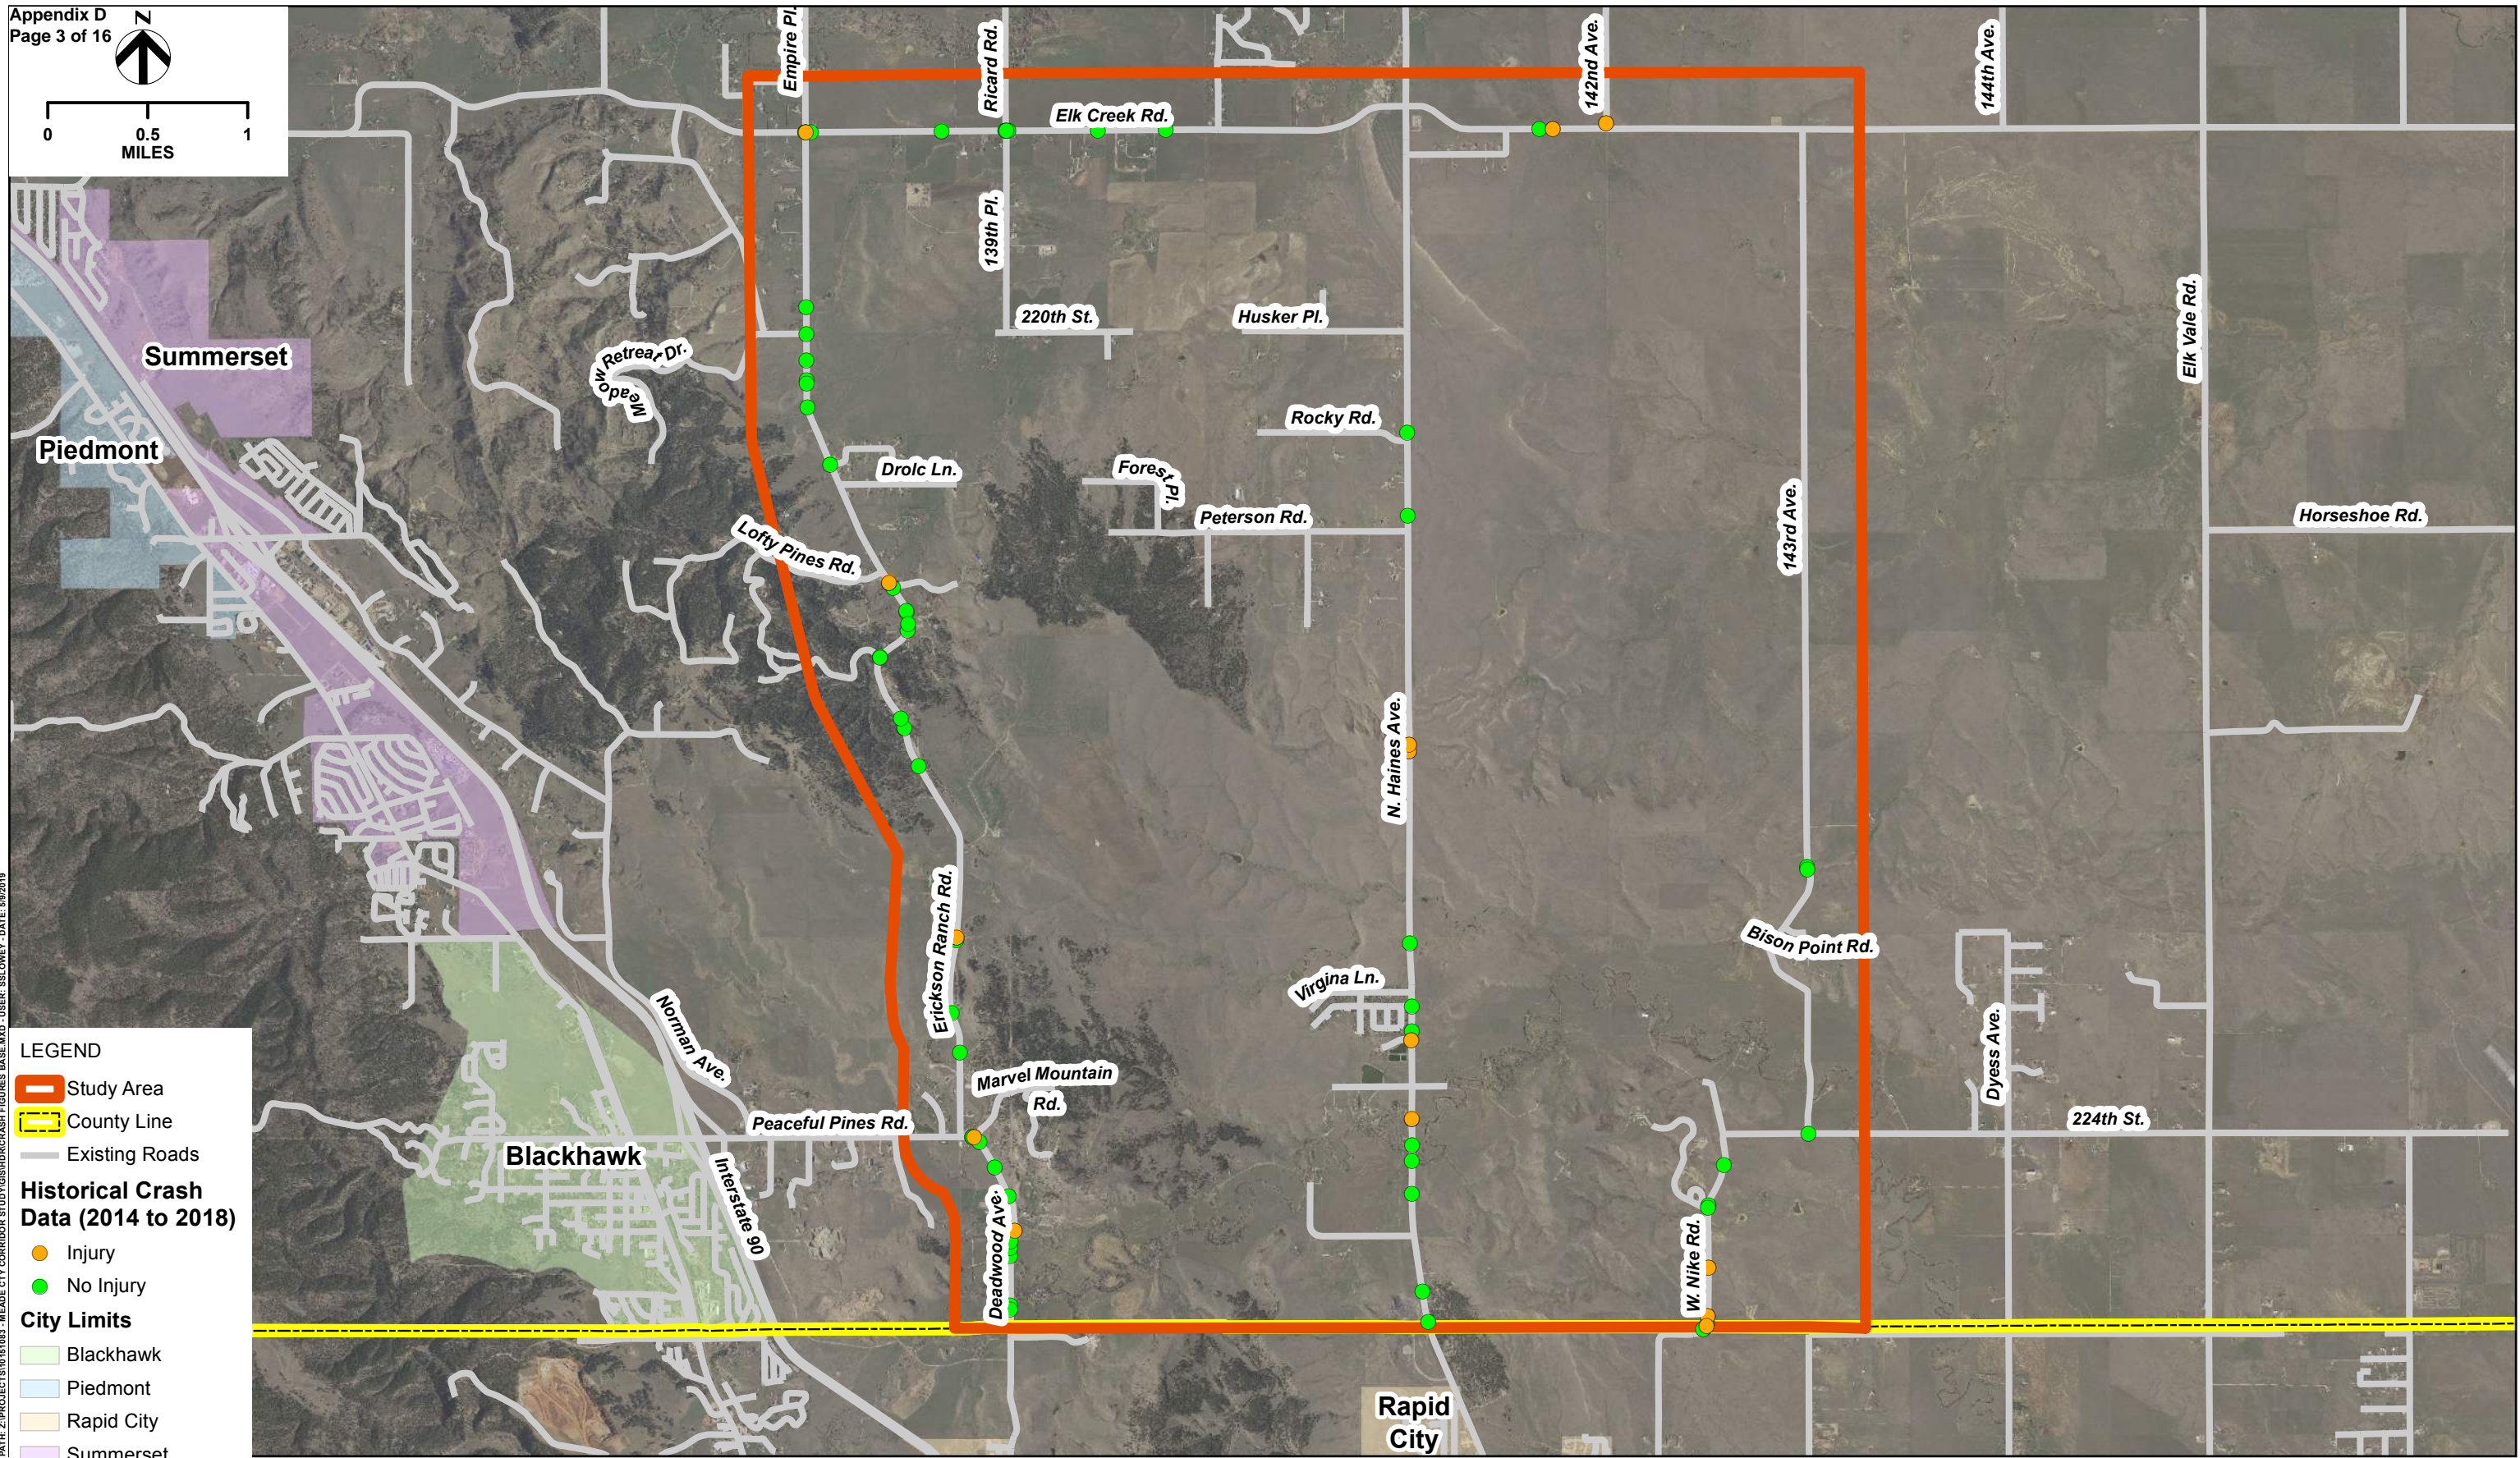
FIGURE
1

Between 2014 and 2018, 74 crashes were reported in the study area on the primary study corridors. These crashes are shown spatially, identified as ‘injury’ or ‘no injury’ crashes, in Figure 1. Zero fatalities were reported within the study area during this timeframe. The appendix includes crash summaries for each of the individual crashes within the study area.

CRASH HISTORY (2014 - 2018)
SOUTHERN MEADE COUNTY CORRIDOR STUDY

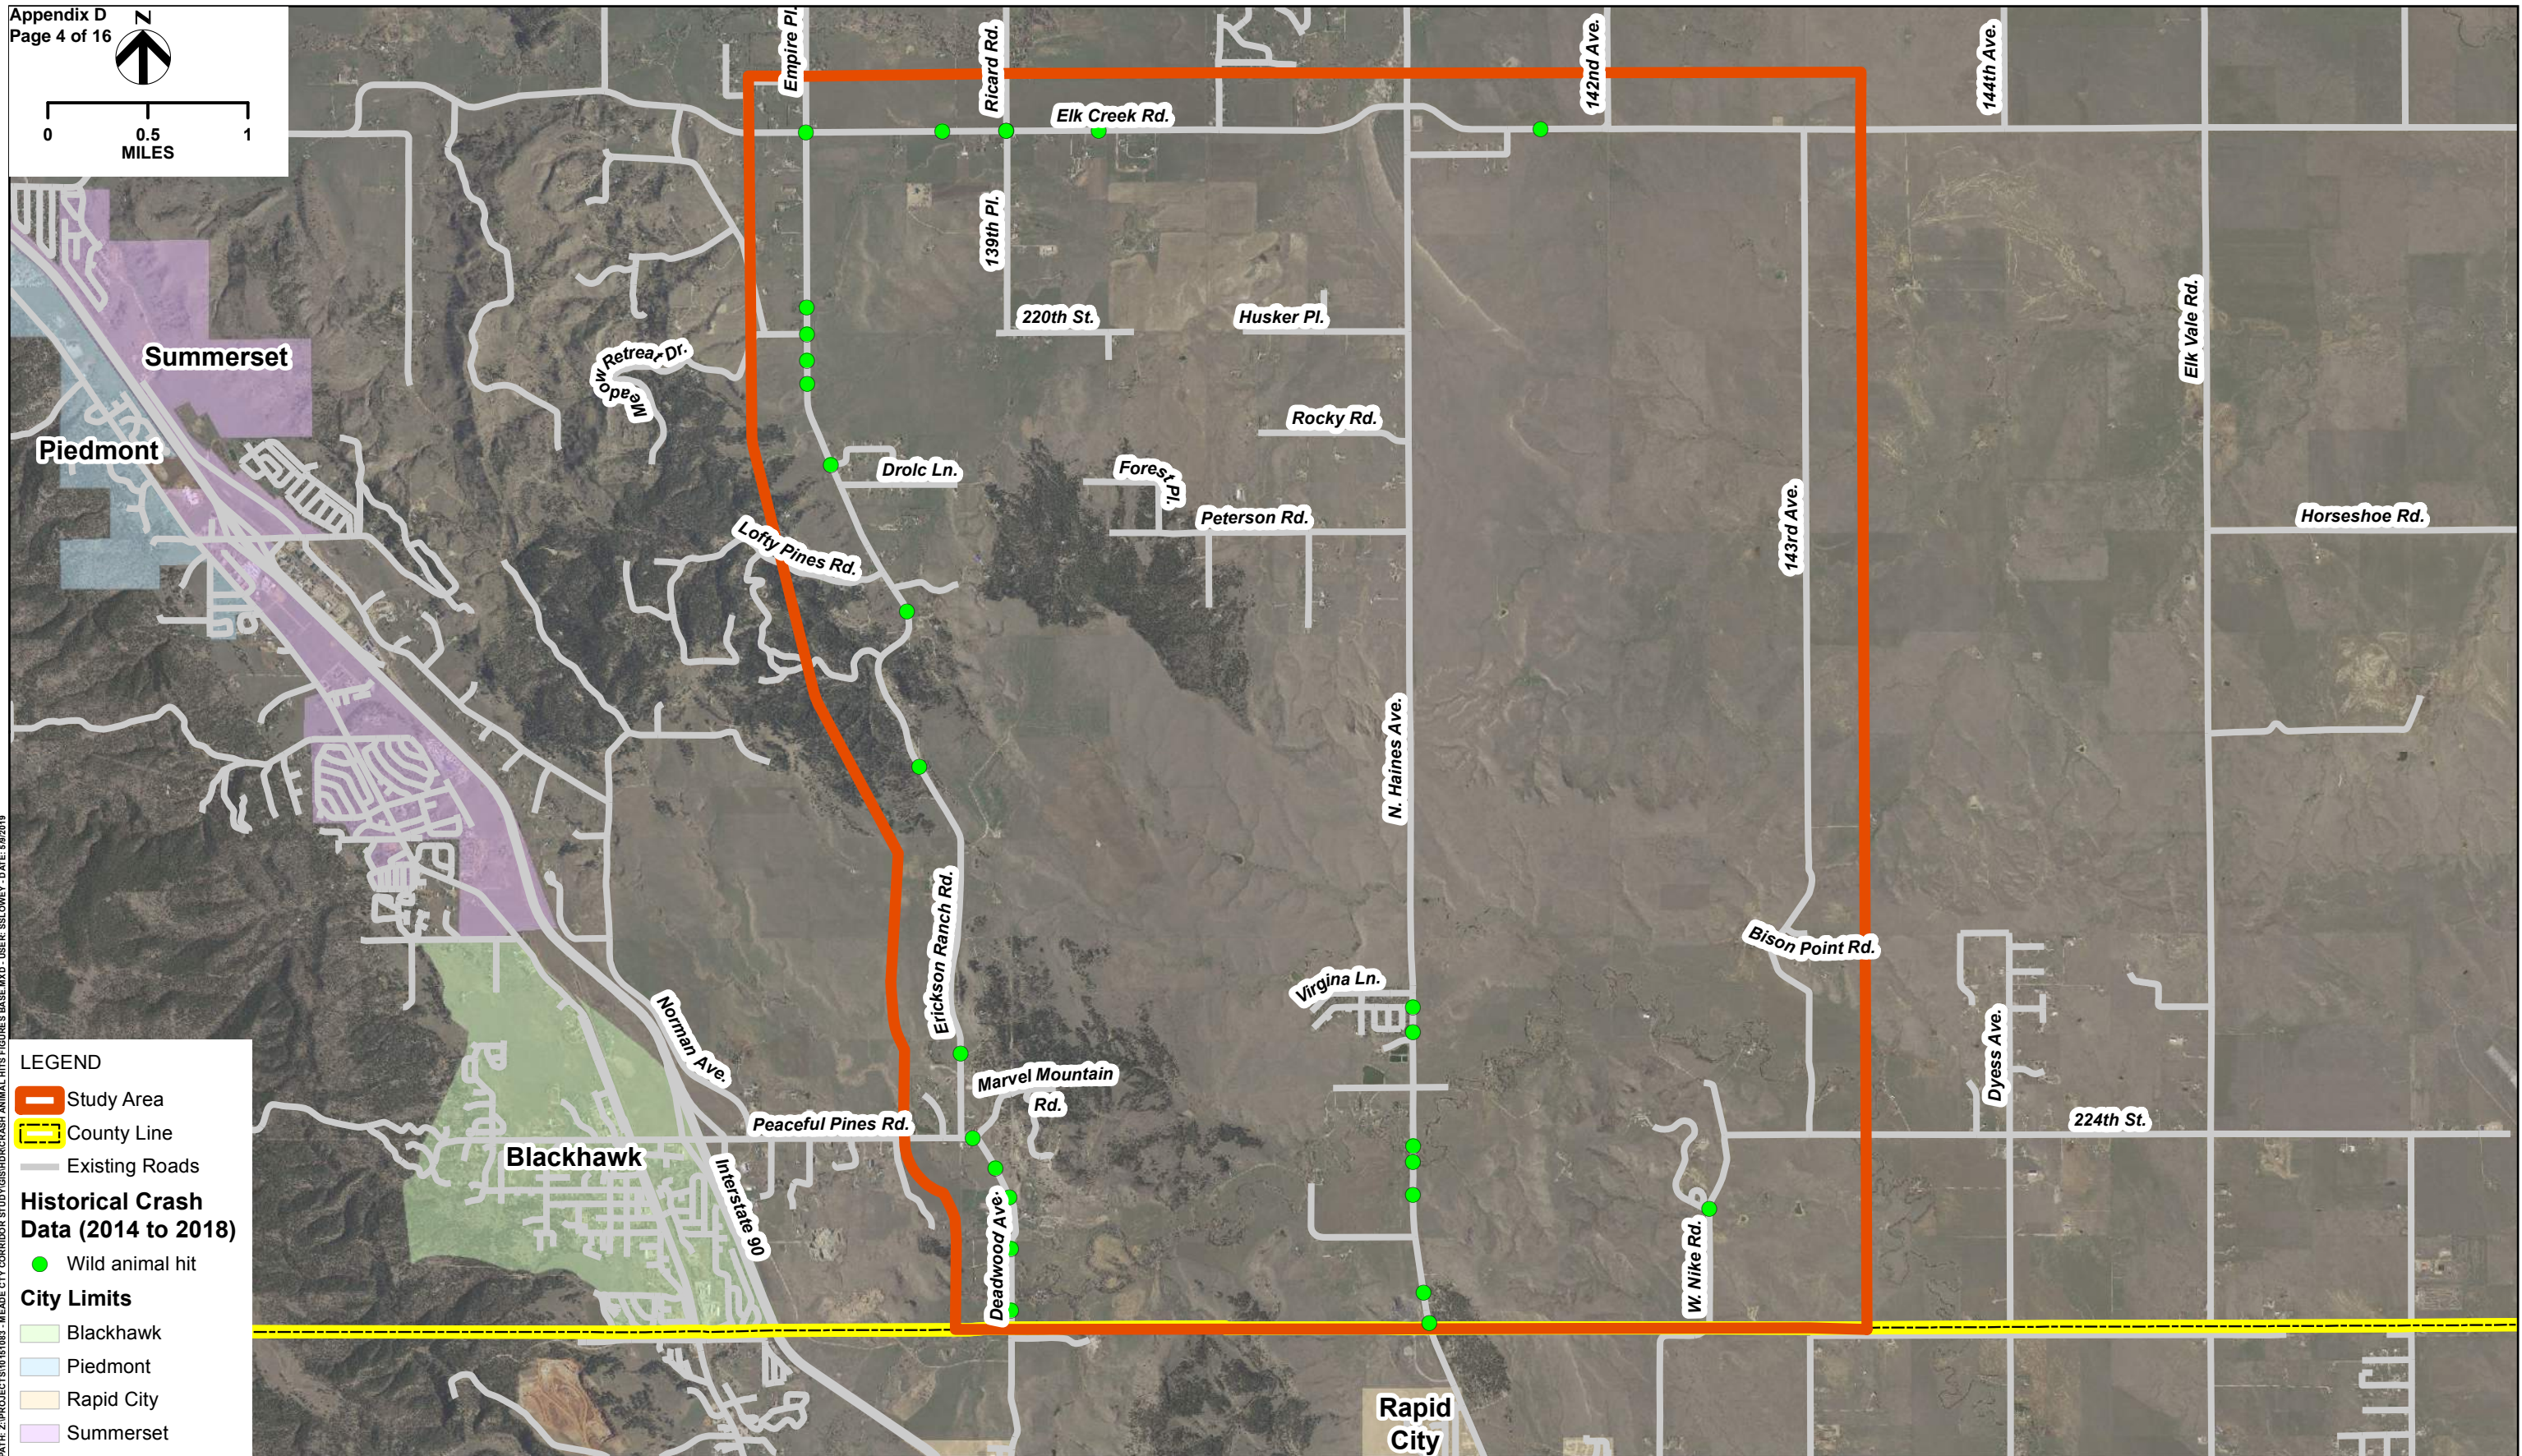
FIGURE
2

Two additional figures are also provided, which are variations of Figure 1. Figure 2 shows only the vehicle-animal crashes and Figure 3 omits the vehicle-animal crashes.

**CRASH HISTORY (2014 - 2018)
VEHICLE-ANIMAL CRASHES**

- Vehicle-animal crashes were the second most-frequent manner of collision (37 percent of all segment crashes).

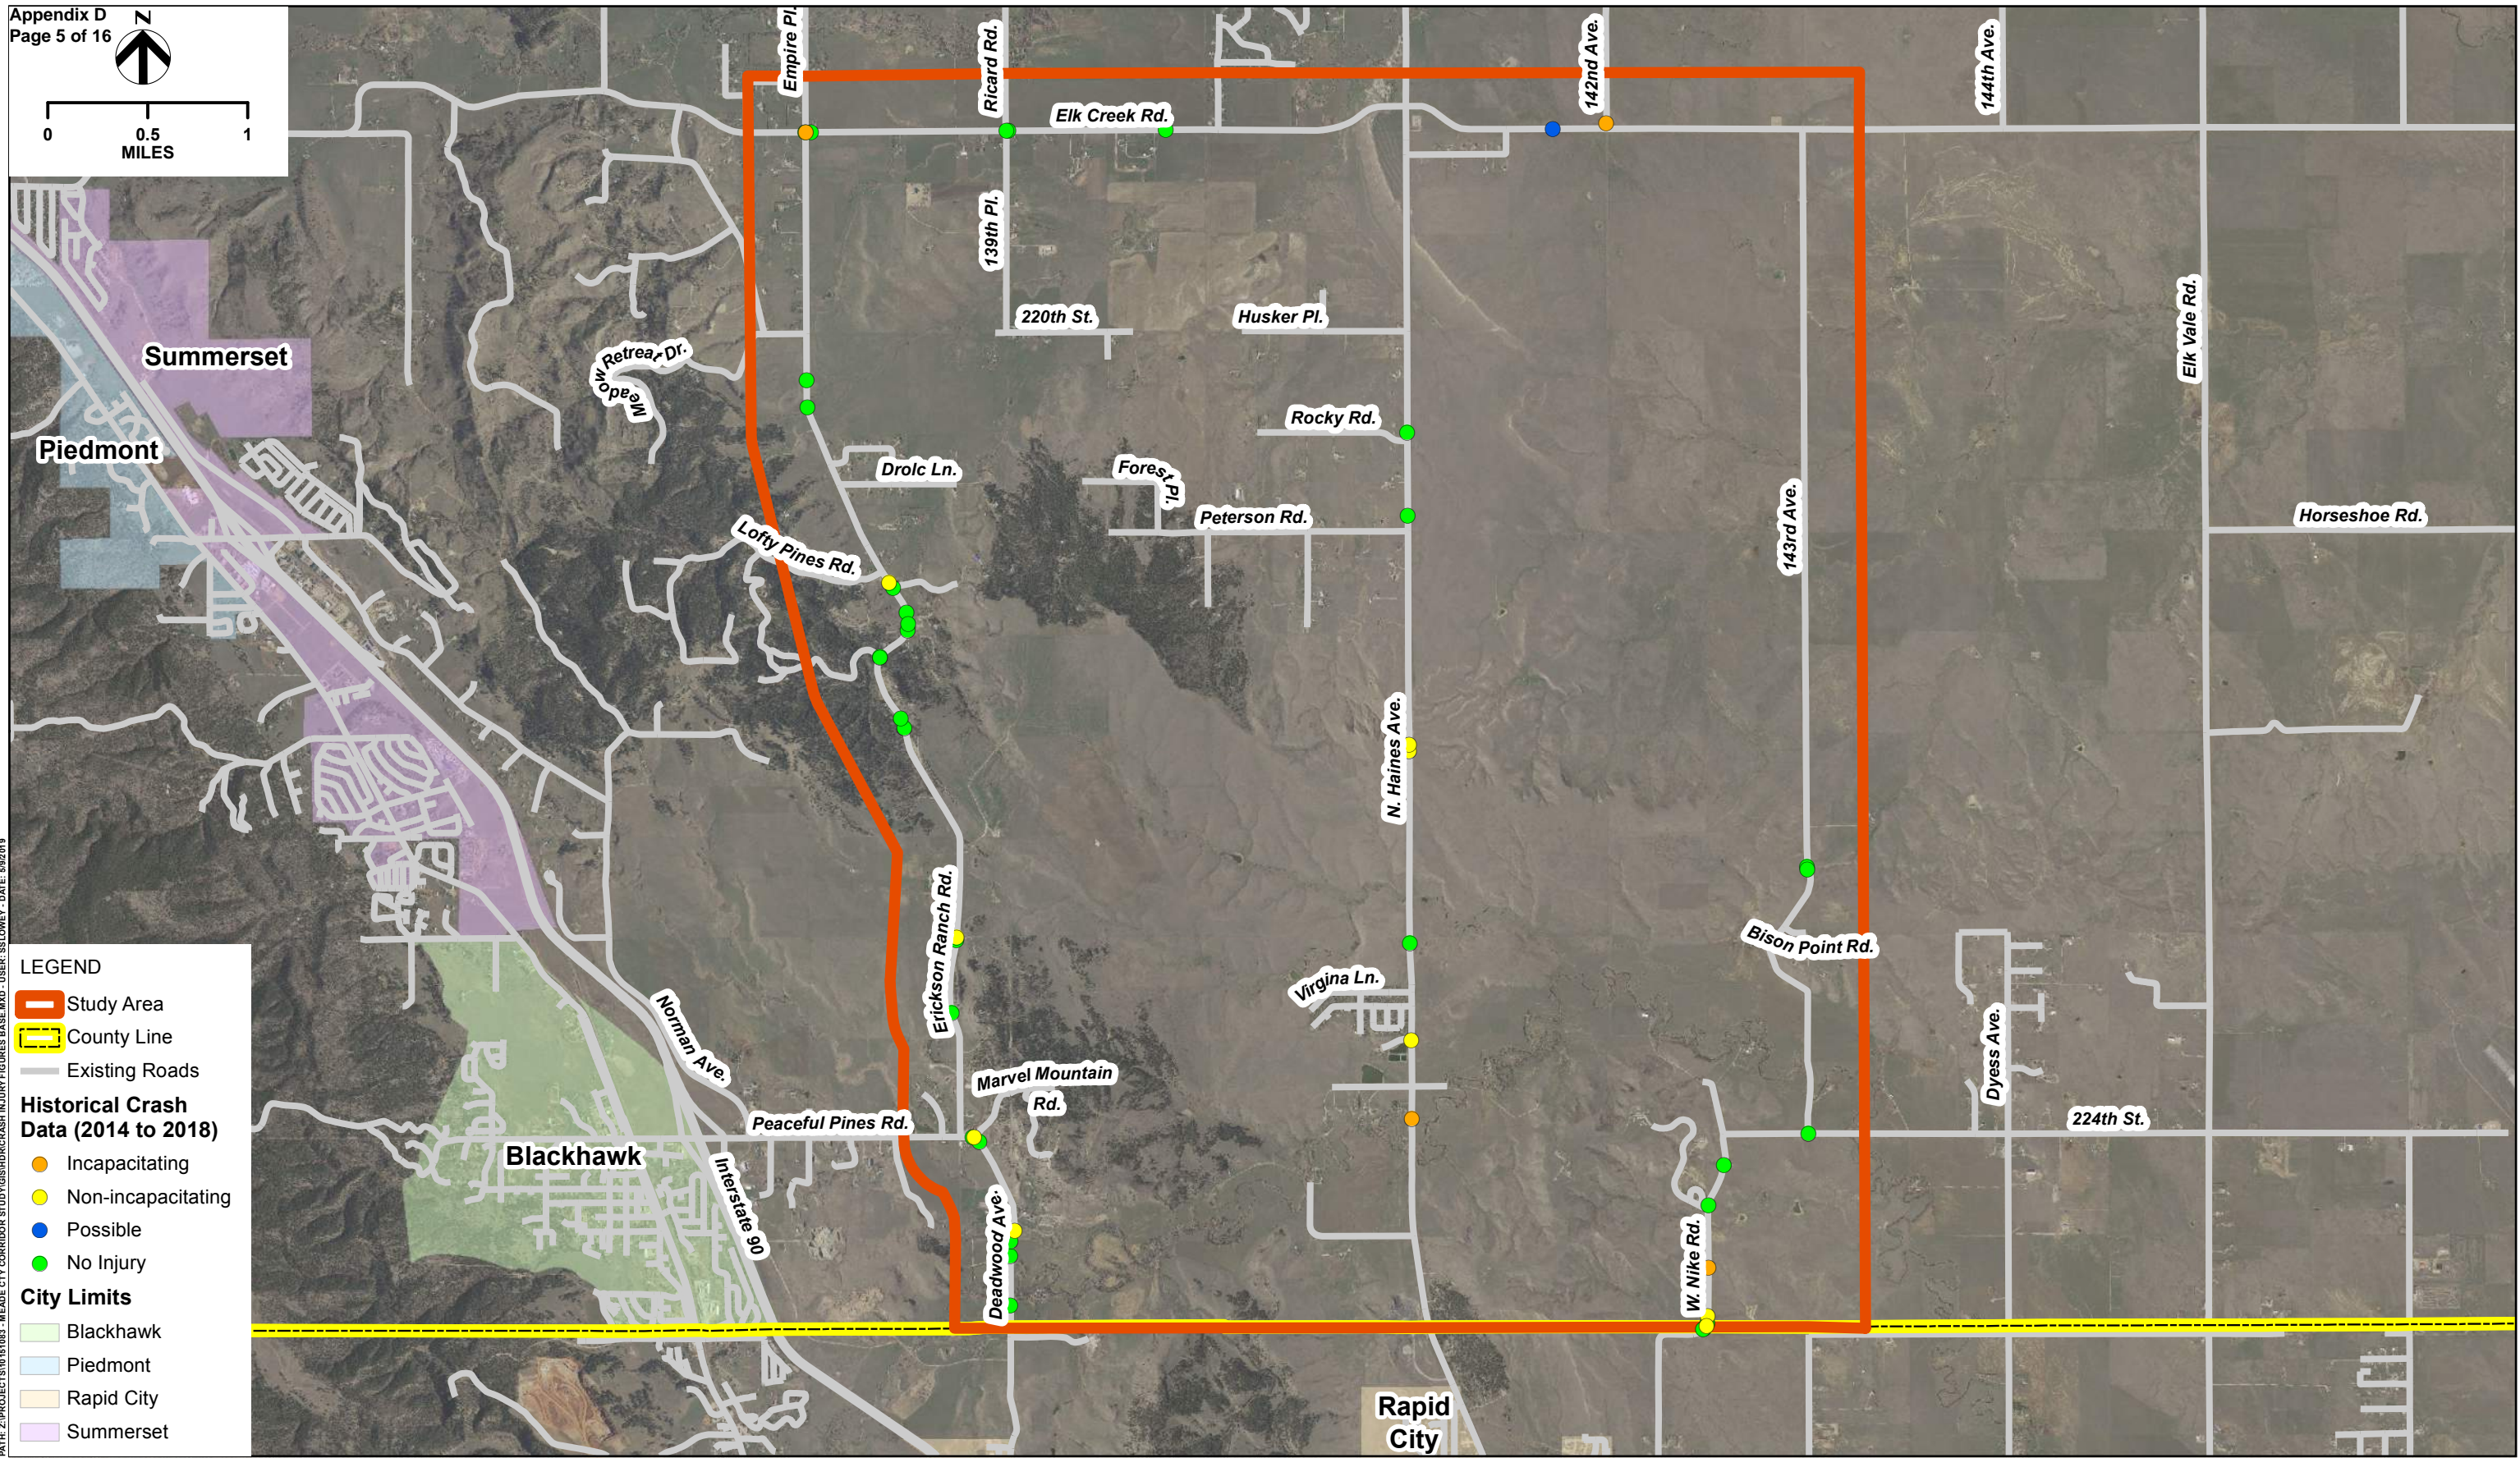
FIGURE
3

**CRASH HISTORY (2014 - 2018)
INJURY SUMMARY
(VEHICLE-ANIMAL CRASHES OMITTED)**
SOUTHERN MEADE COUNTY CORRIDOR STUDY

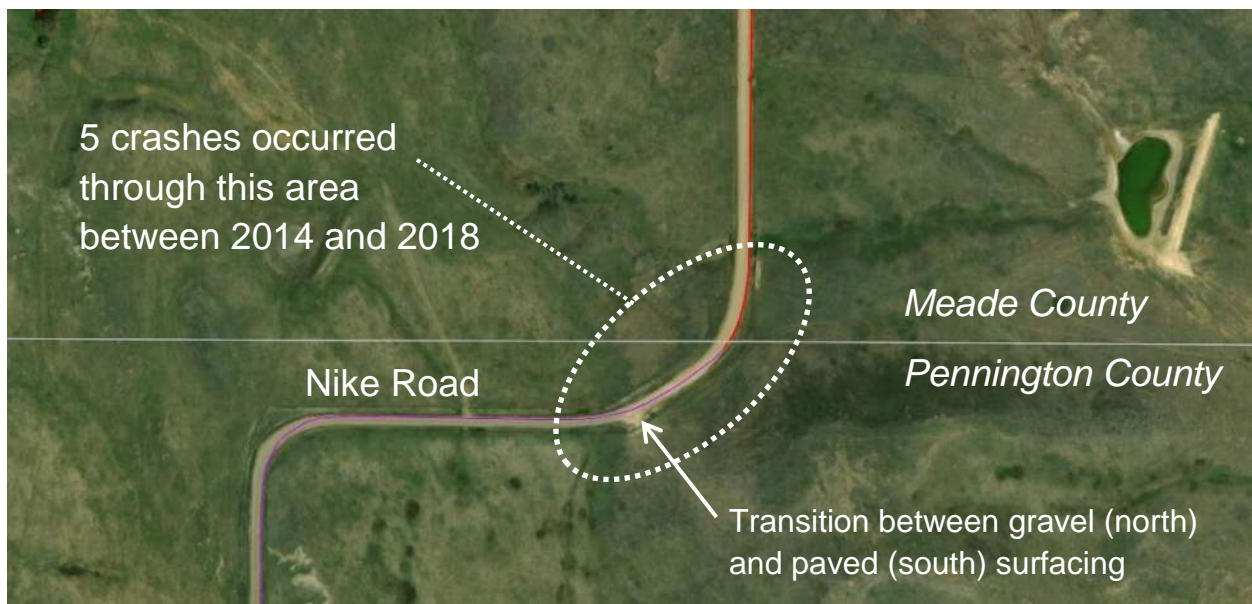
Five of the 10 crashes occurred along the horizontal curve that crosses the Meade County/Pennington County boundary, shown in Figure 4. Two of these crashes occurred on the Pennington County side of the horizontal curve, but were included in this analysis to provide a complete review of the curve.

All five crashes were single-vehicle roadway departure crashes and four of the five involved a northbound vehicle. Vehicles traveling northbound approach the curve on a paved, 2-lane roadway, but the roadway transitions to gravel at the onset of the horizontal curvature. This can create a difficult situation for motorists when high speeds are involved. Four of the five crashes noted driving too fast for conditions and/or over-correcting/over-steering as a driver contributing circumstance. The fifth crash involved alcohol and careless driving.

Figure 4: Nike Road Horizontal Curve at Meade County/Pennington County Boundary
