Rapid City Arterial Street Safety Study

Final Report

March 2012

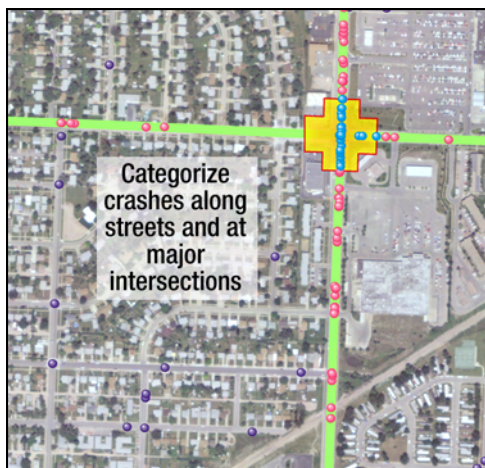
Figure 4. Classification of Crash Data Points

- Crashes were identified as occurring within a major intersection influence area or along an arterial segment, and those occurring at a major intersection were removed from further consideration. Crashes that occurred along each of the 249 arterial segments were retained for further study. **Figure 4** shows an example of arterial segment crashes as well as the intersection related crashes removed from the analysis.

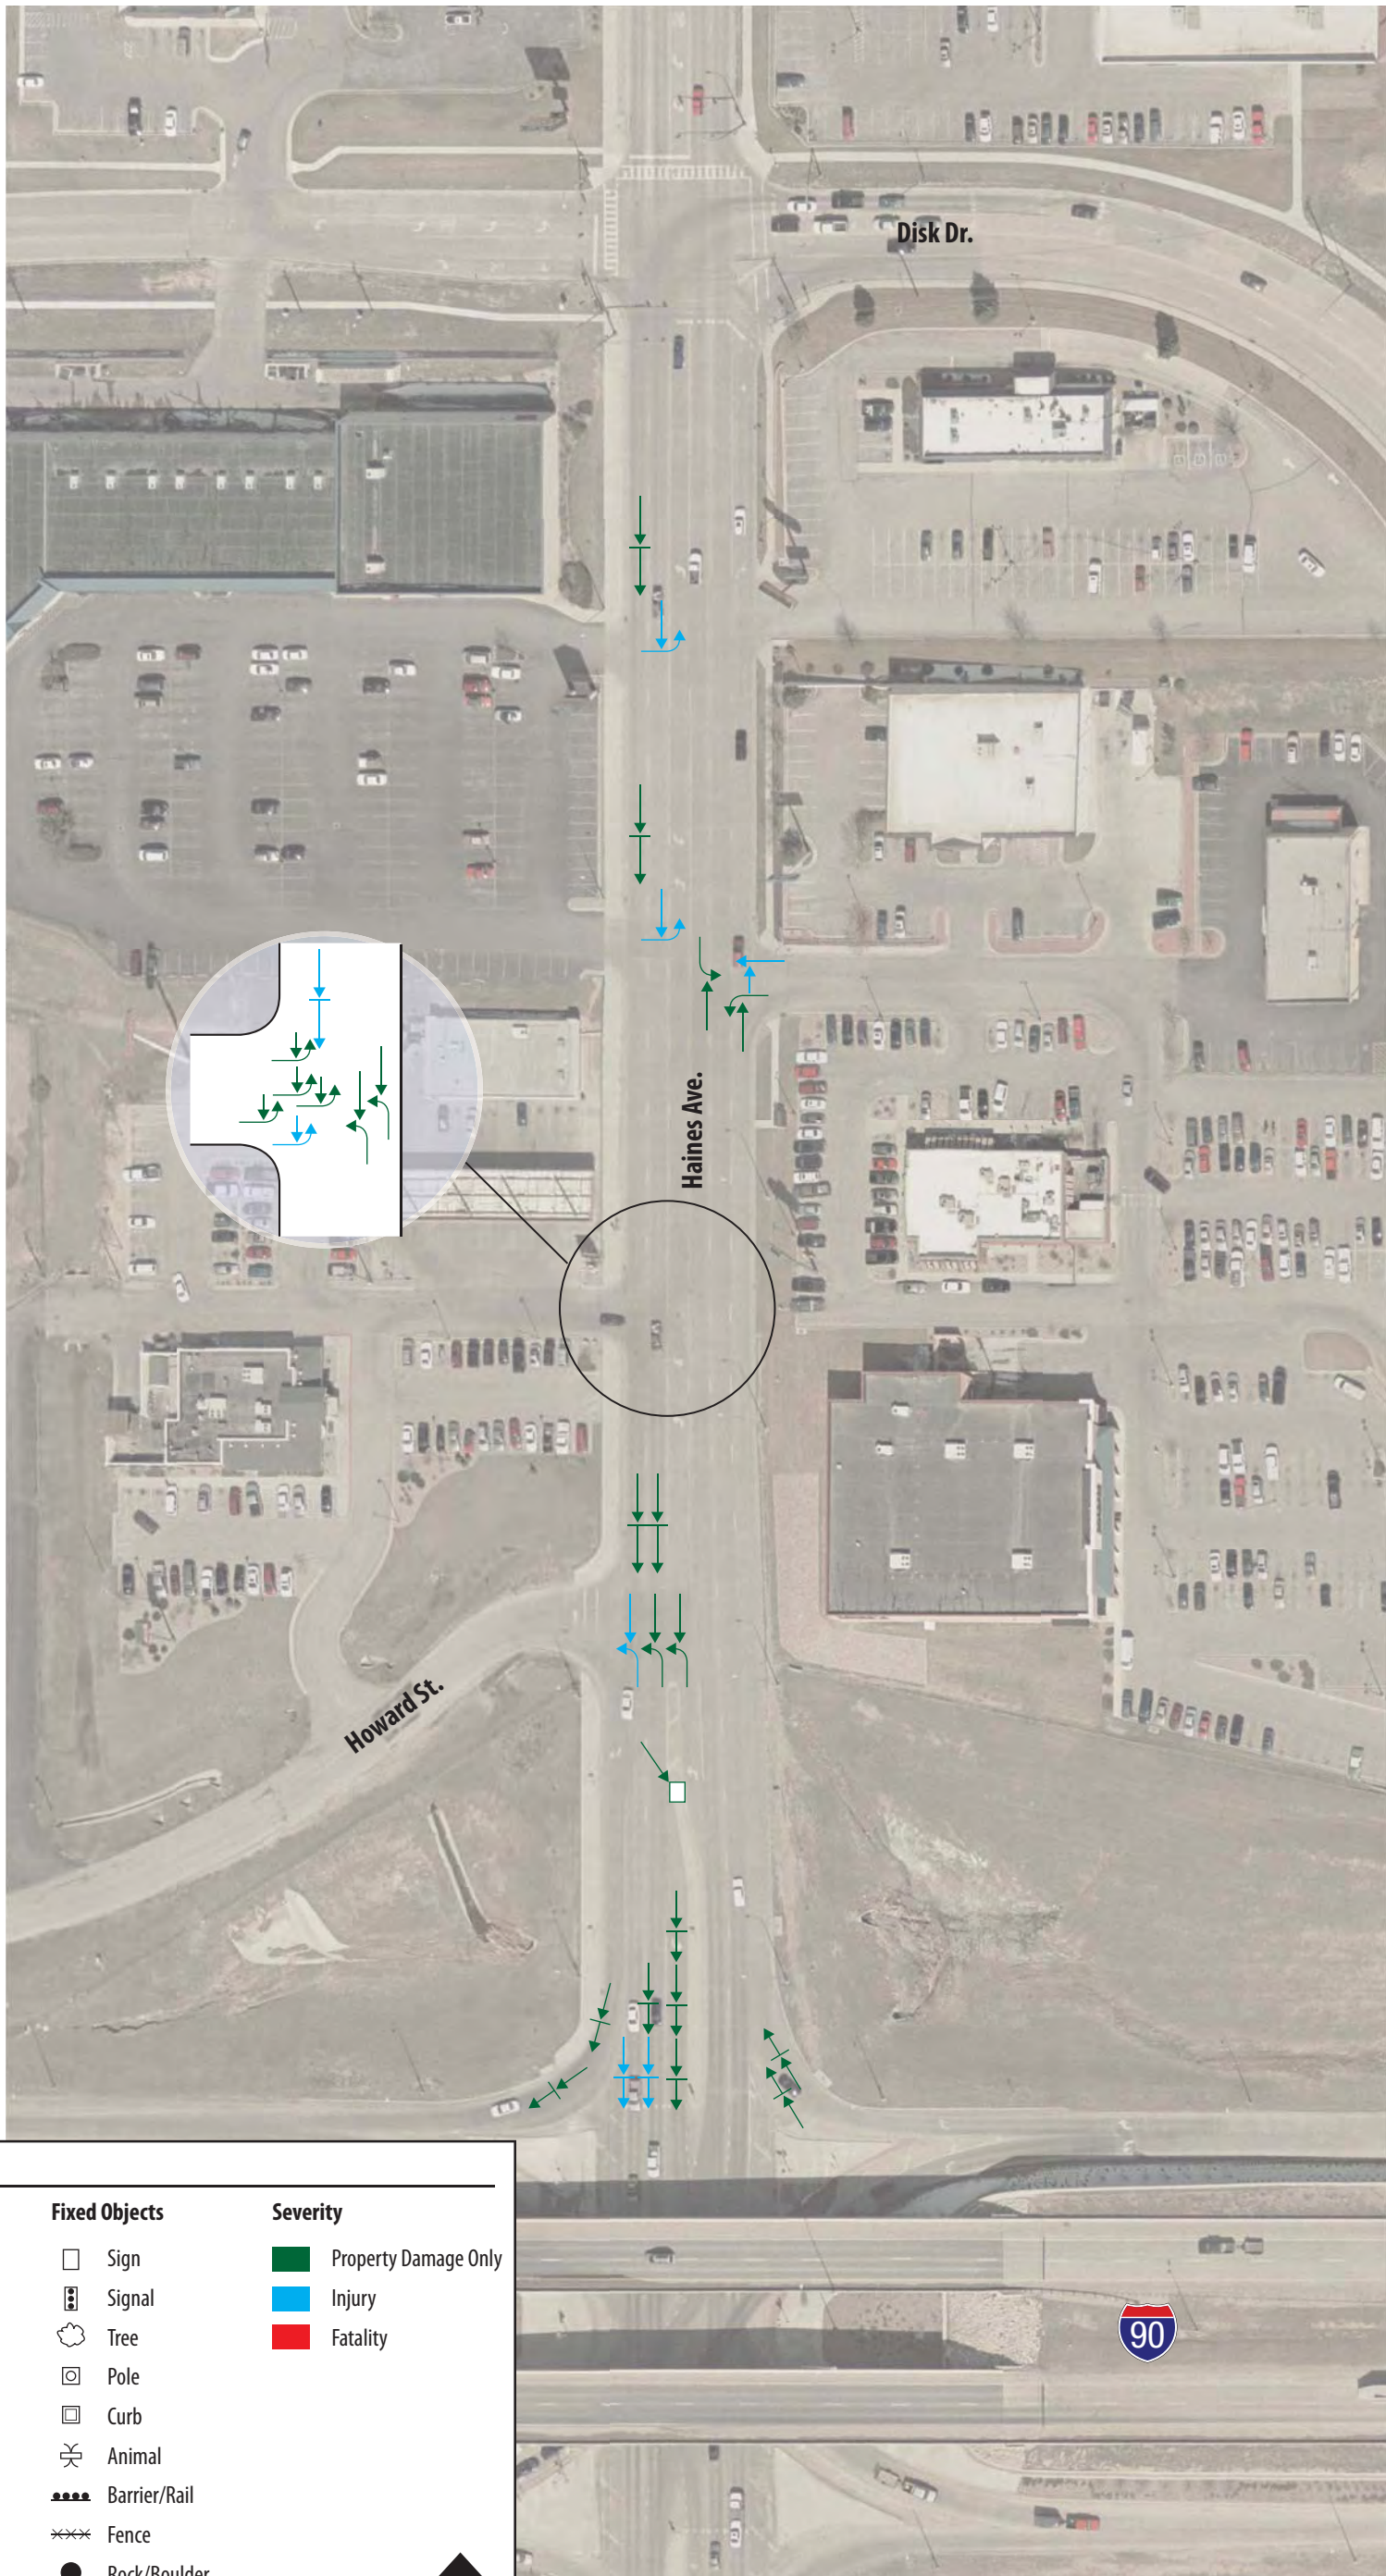
APPENDIX C HAINES AVENUE – I-90 TO DISK DRIVE

During the three-year study period, there were a total of 31 crashes on this segment. Of these, 23 were PDO crashes and 8 were injury crashes. There were no fatal crashes on this segment during the study period. There were an even split between angle type and rear end type crashes on this segment. A diagram showing the type and location of each crash for this segment can be found in **Appendix C**.

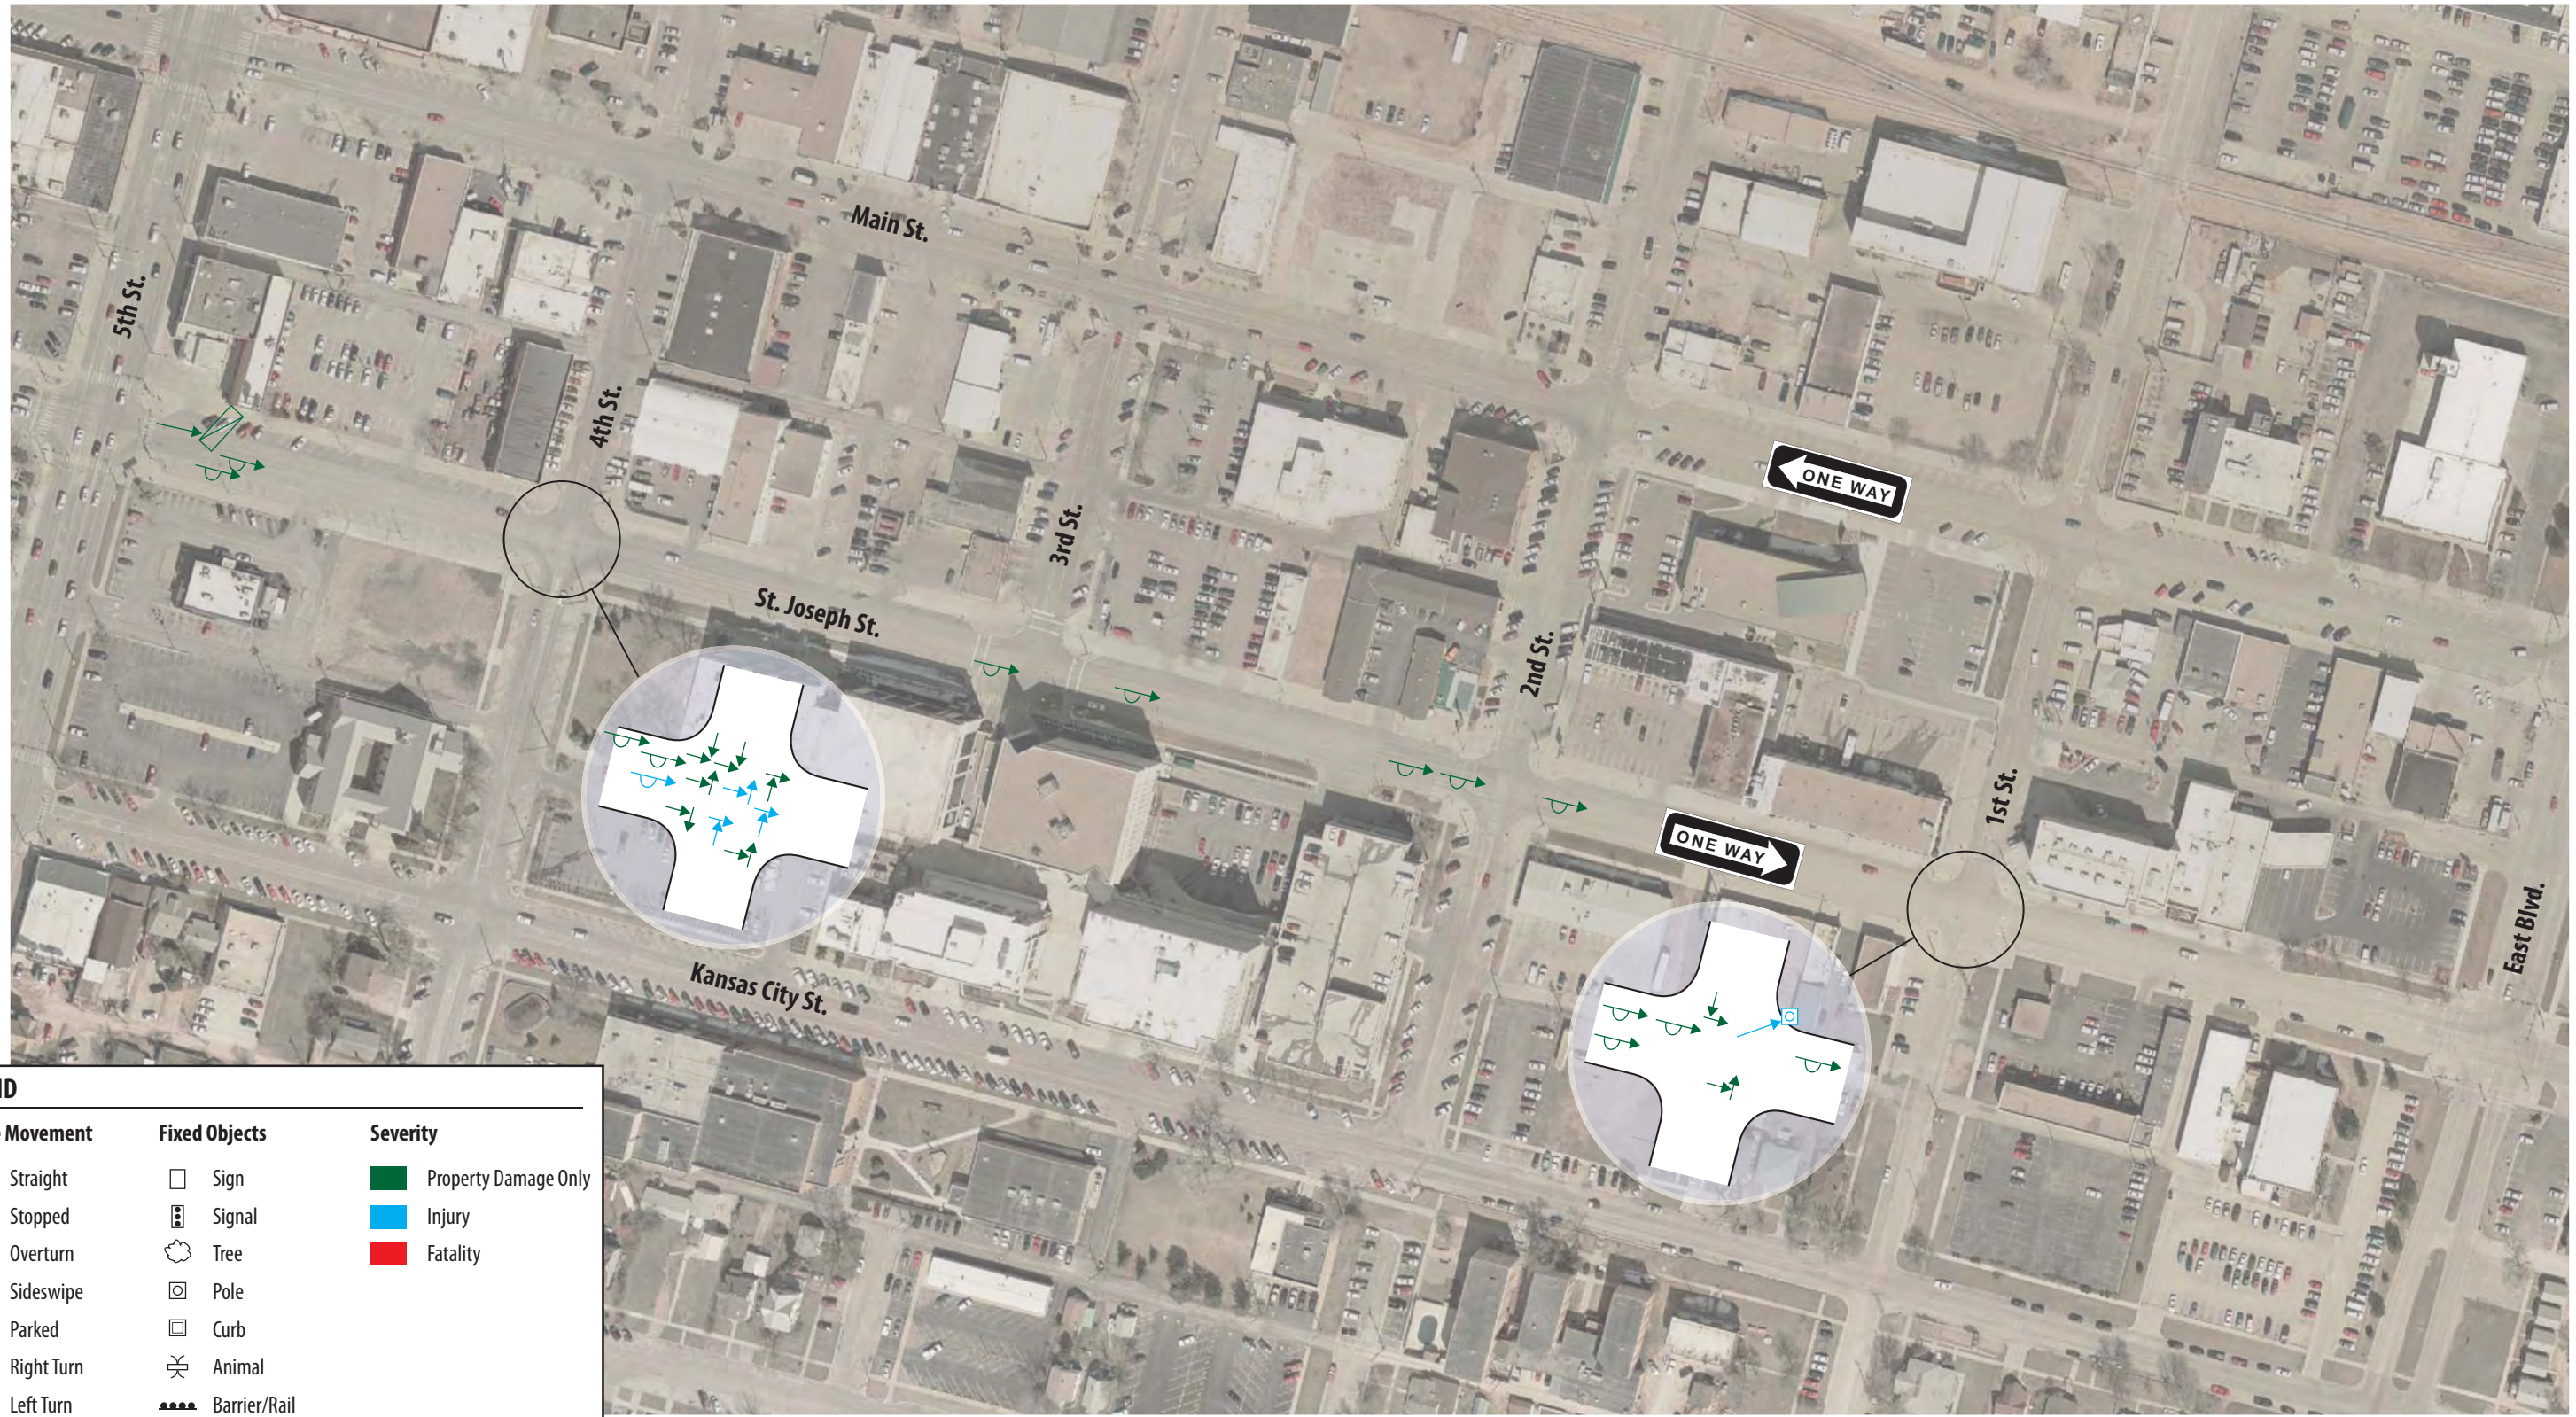
APPENDIX D ST. JOSEPH STREET – 5TH TO EAST BOULEVARD

During the three-year study period, there were a total of 27 crashes on this segment. Of these, 22 were PDO crashes and 5 were injury crashes. There were no fatal crashes on this segment during the study period. The most predominant crash type were sideswipe same direction crashes (13) followed closely by broadside type crashes (11). A diagram showing the type and location of each crash for this segment can be found in **Appendix D**.

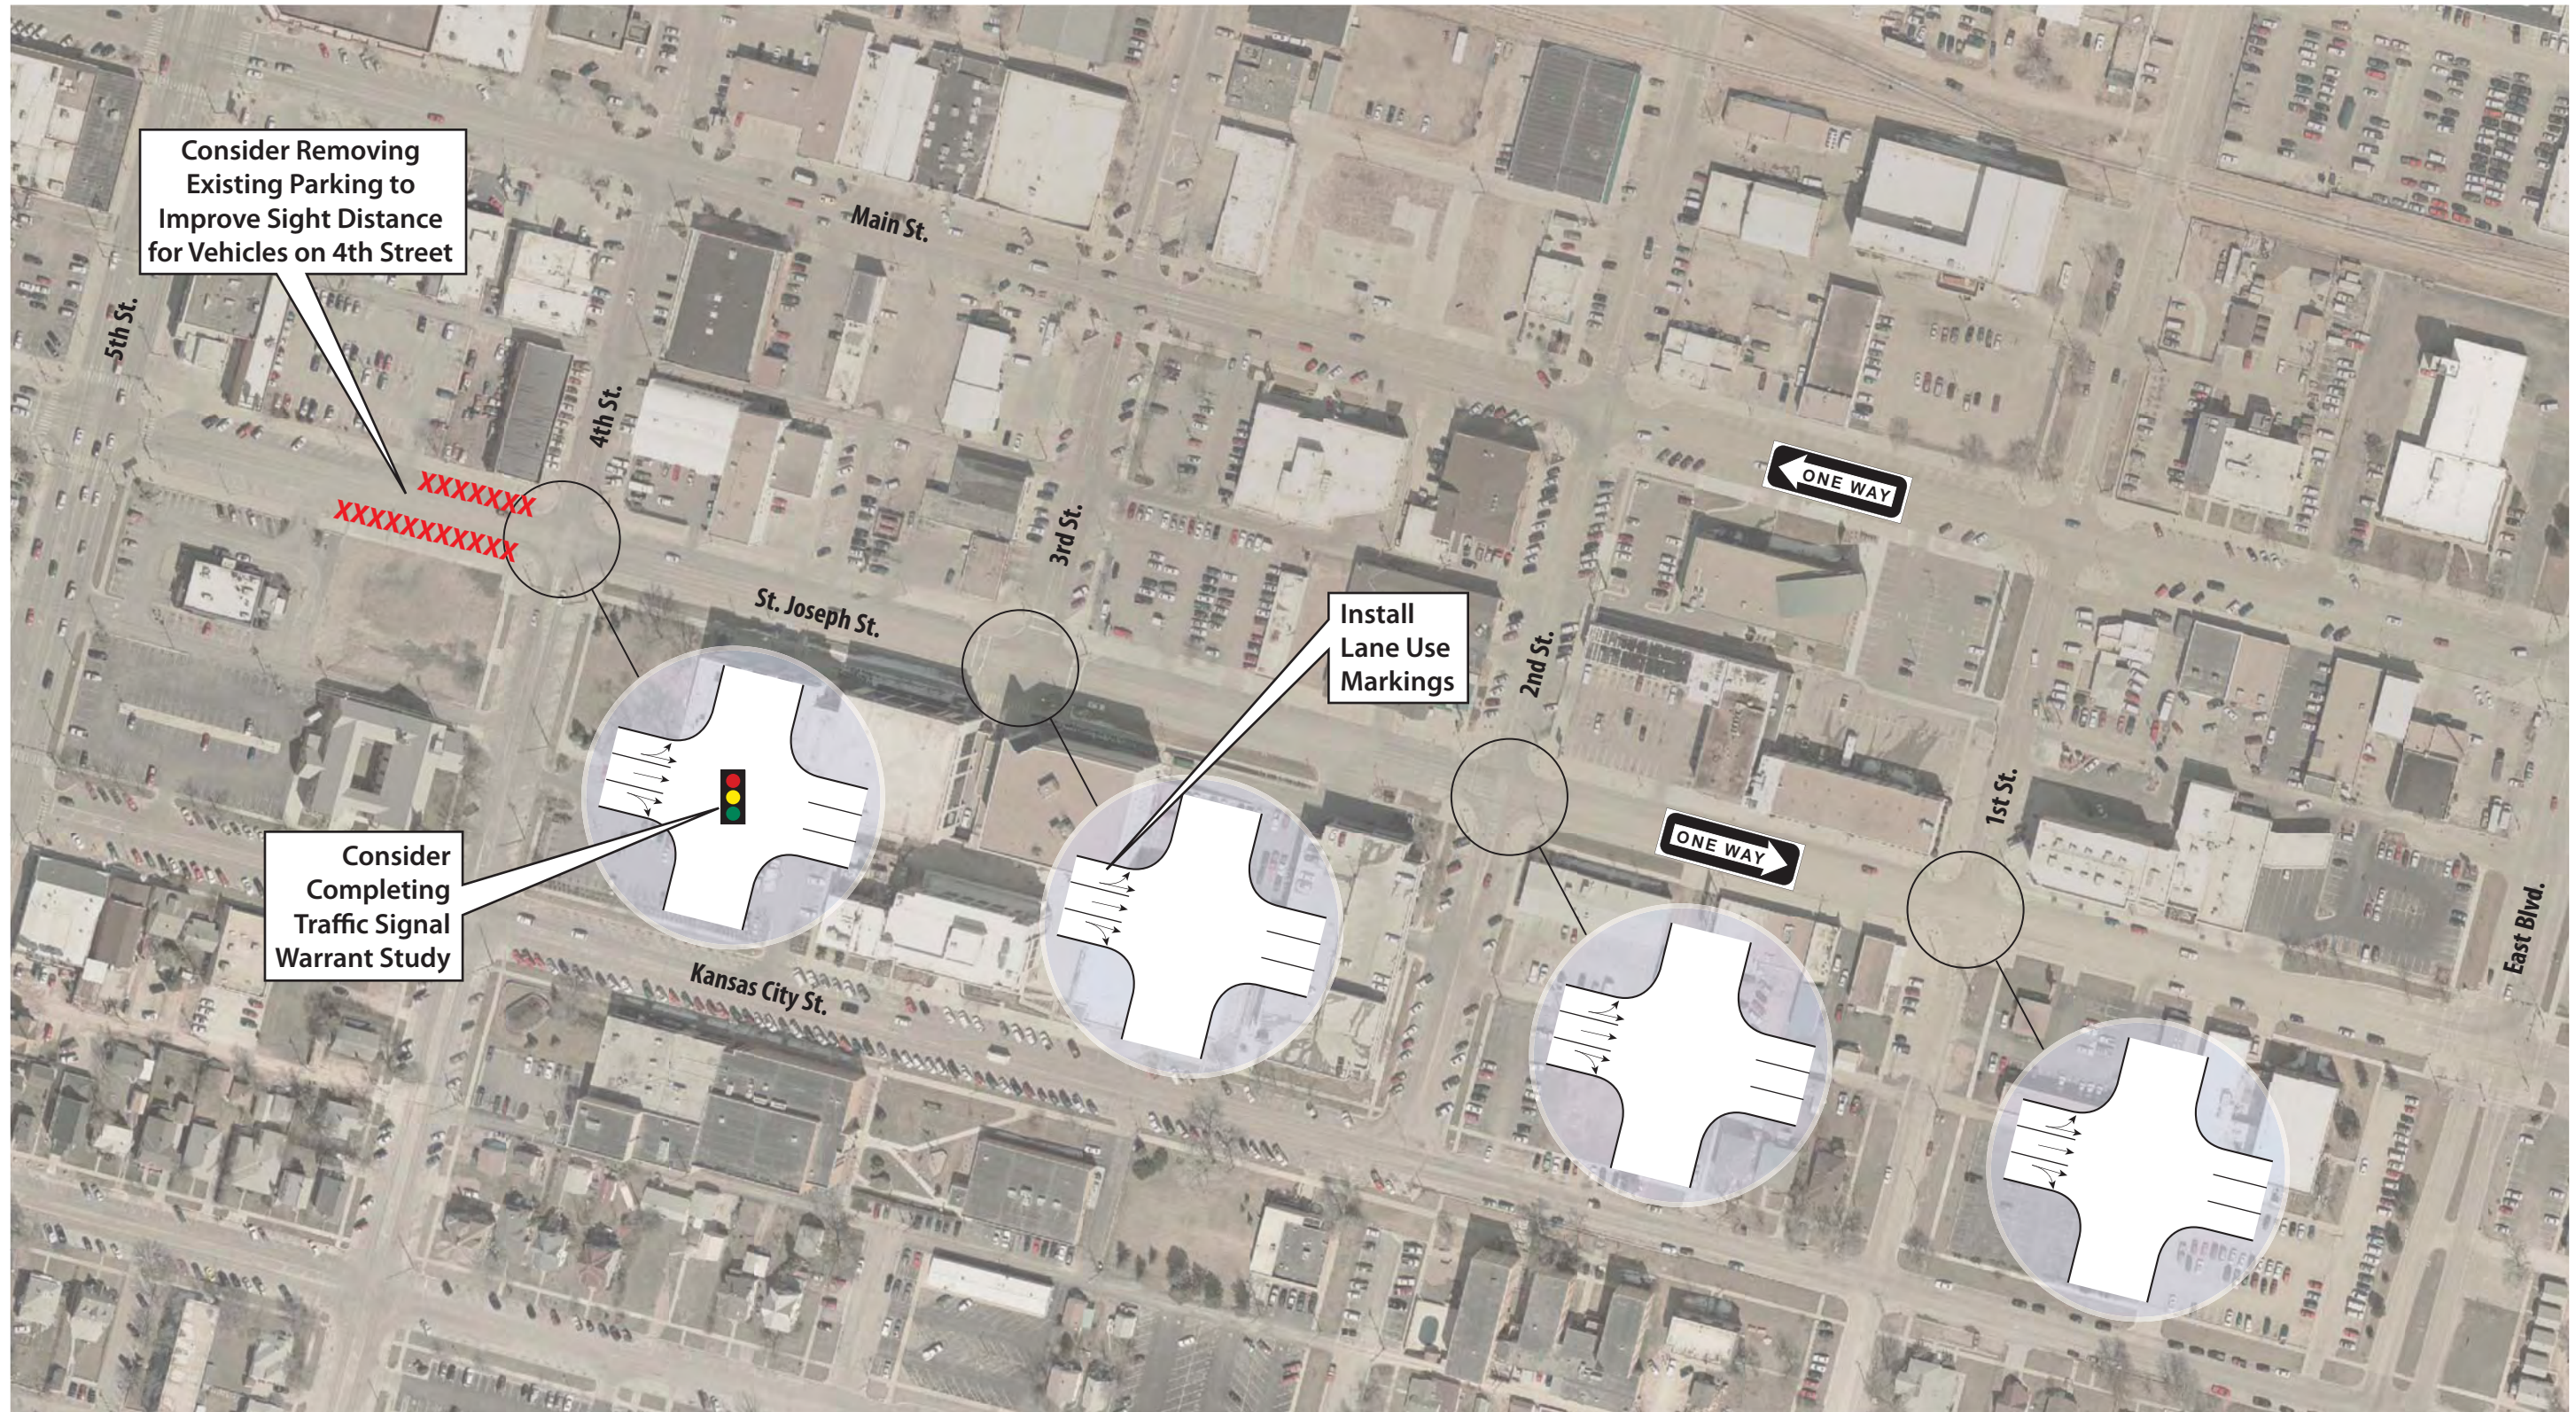
Segment 3
Saint Joseph Street -
5th Street to East Boulevard

A concept showing both the proposed traffic signal and striping developed for this segment can be found in **Appendix D**.

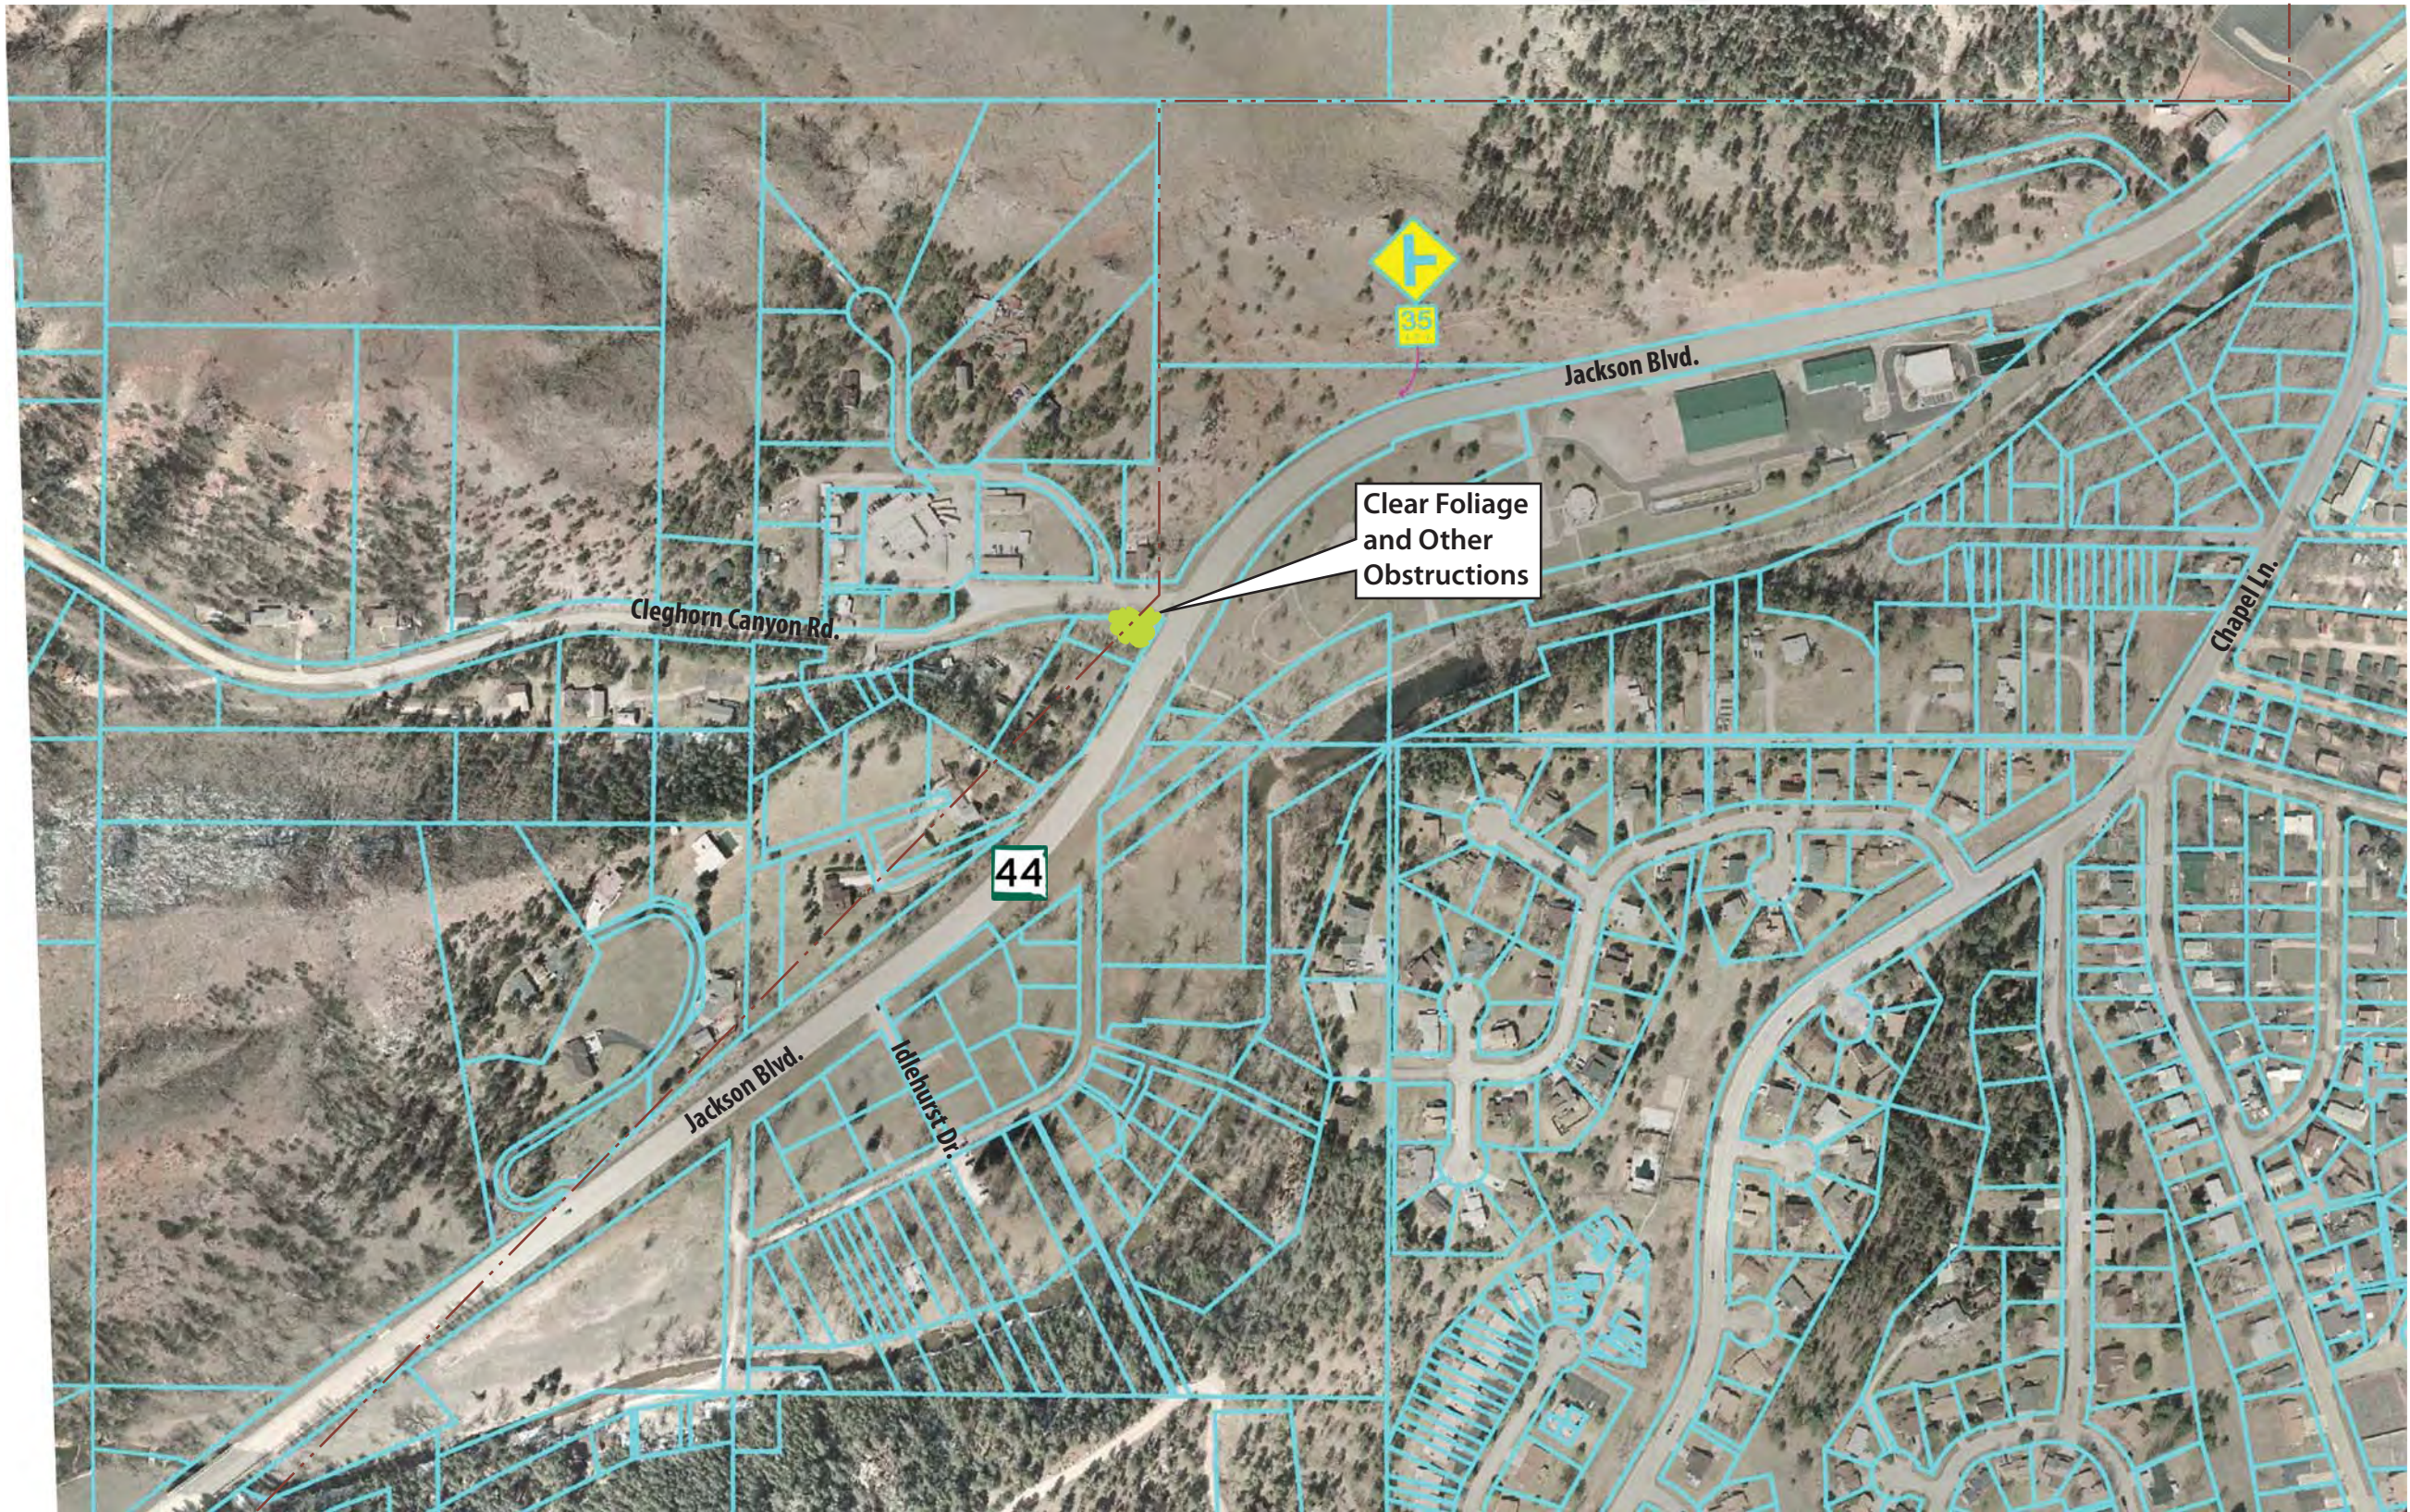
Concept for Segment 4
SD 44 (Jackson Boulevard) -
City Limit to Chapel Lane

A concept showing the recommended signing and striping for this segment can be found in **Appendix E**.

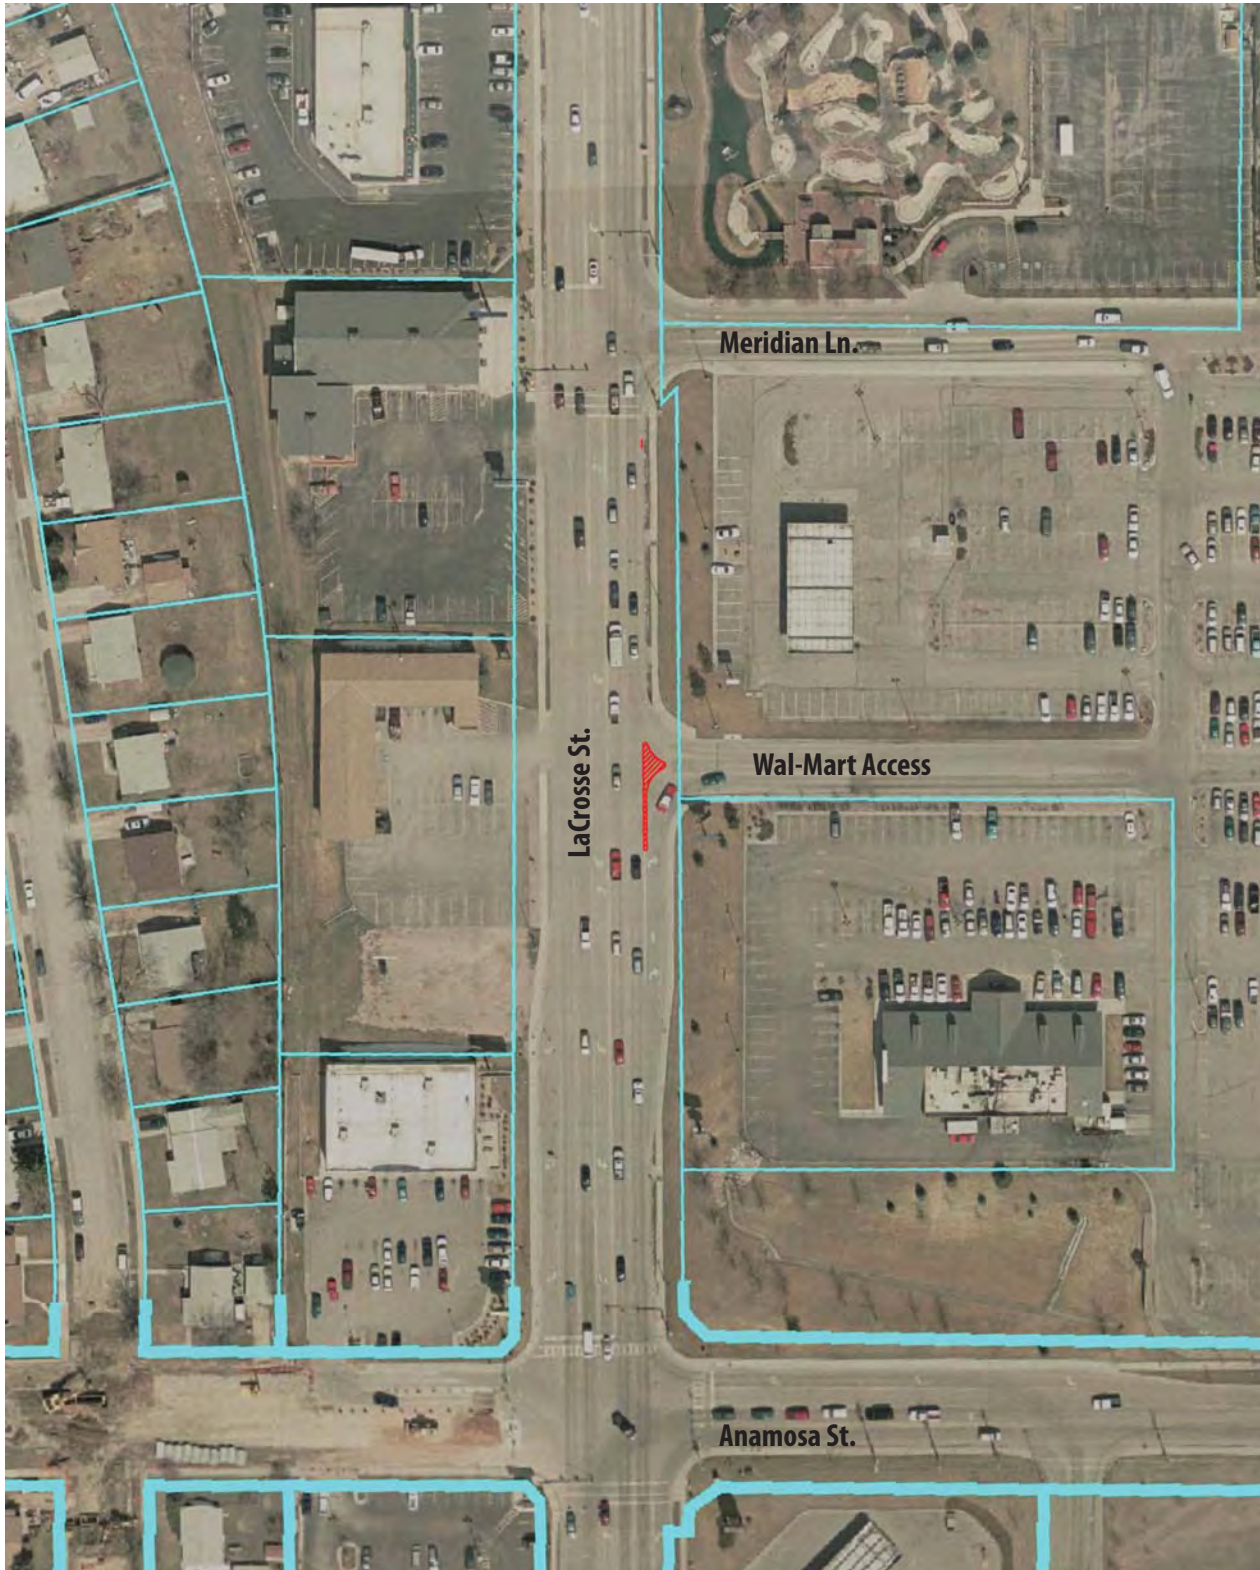
Segment 6
LaCrosse Street -
Anamosa Street to Meridian Lane

Based on the concentration of crashes at the unsignalized Wal-Mart access primarily related to the number of angle crashes at this location, consideration should be given to restricting the driveway to a right-in / right-out access only. A concept of the new configuration of this access can be found in **Appendix G**. If implemented, this concept would construct a raised channelization island. The implementation of this concept would assist compliance and reduce the number of broadside crashes at this intersection. It is also worth noting that this shopping center will still have a full movement signalized access at Meridian Lane at which exiting vehicles can head south on LaCrosse Street.

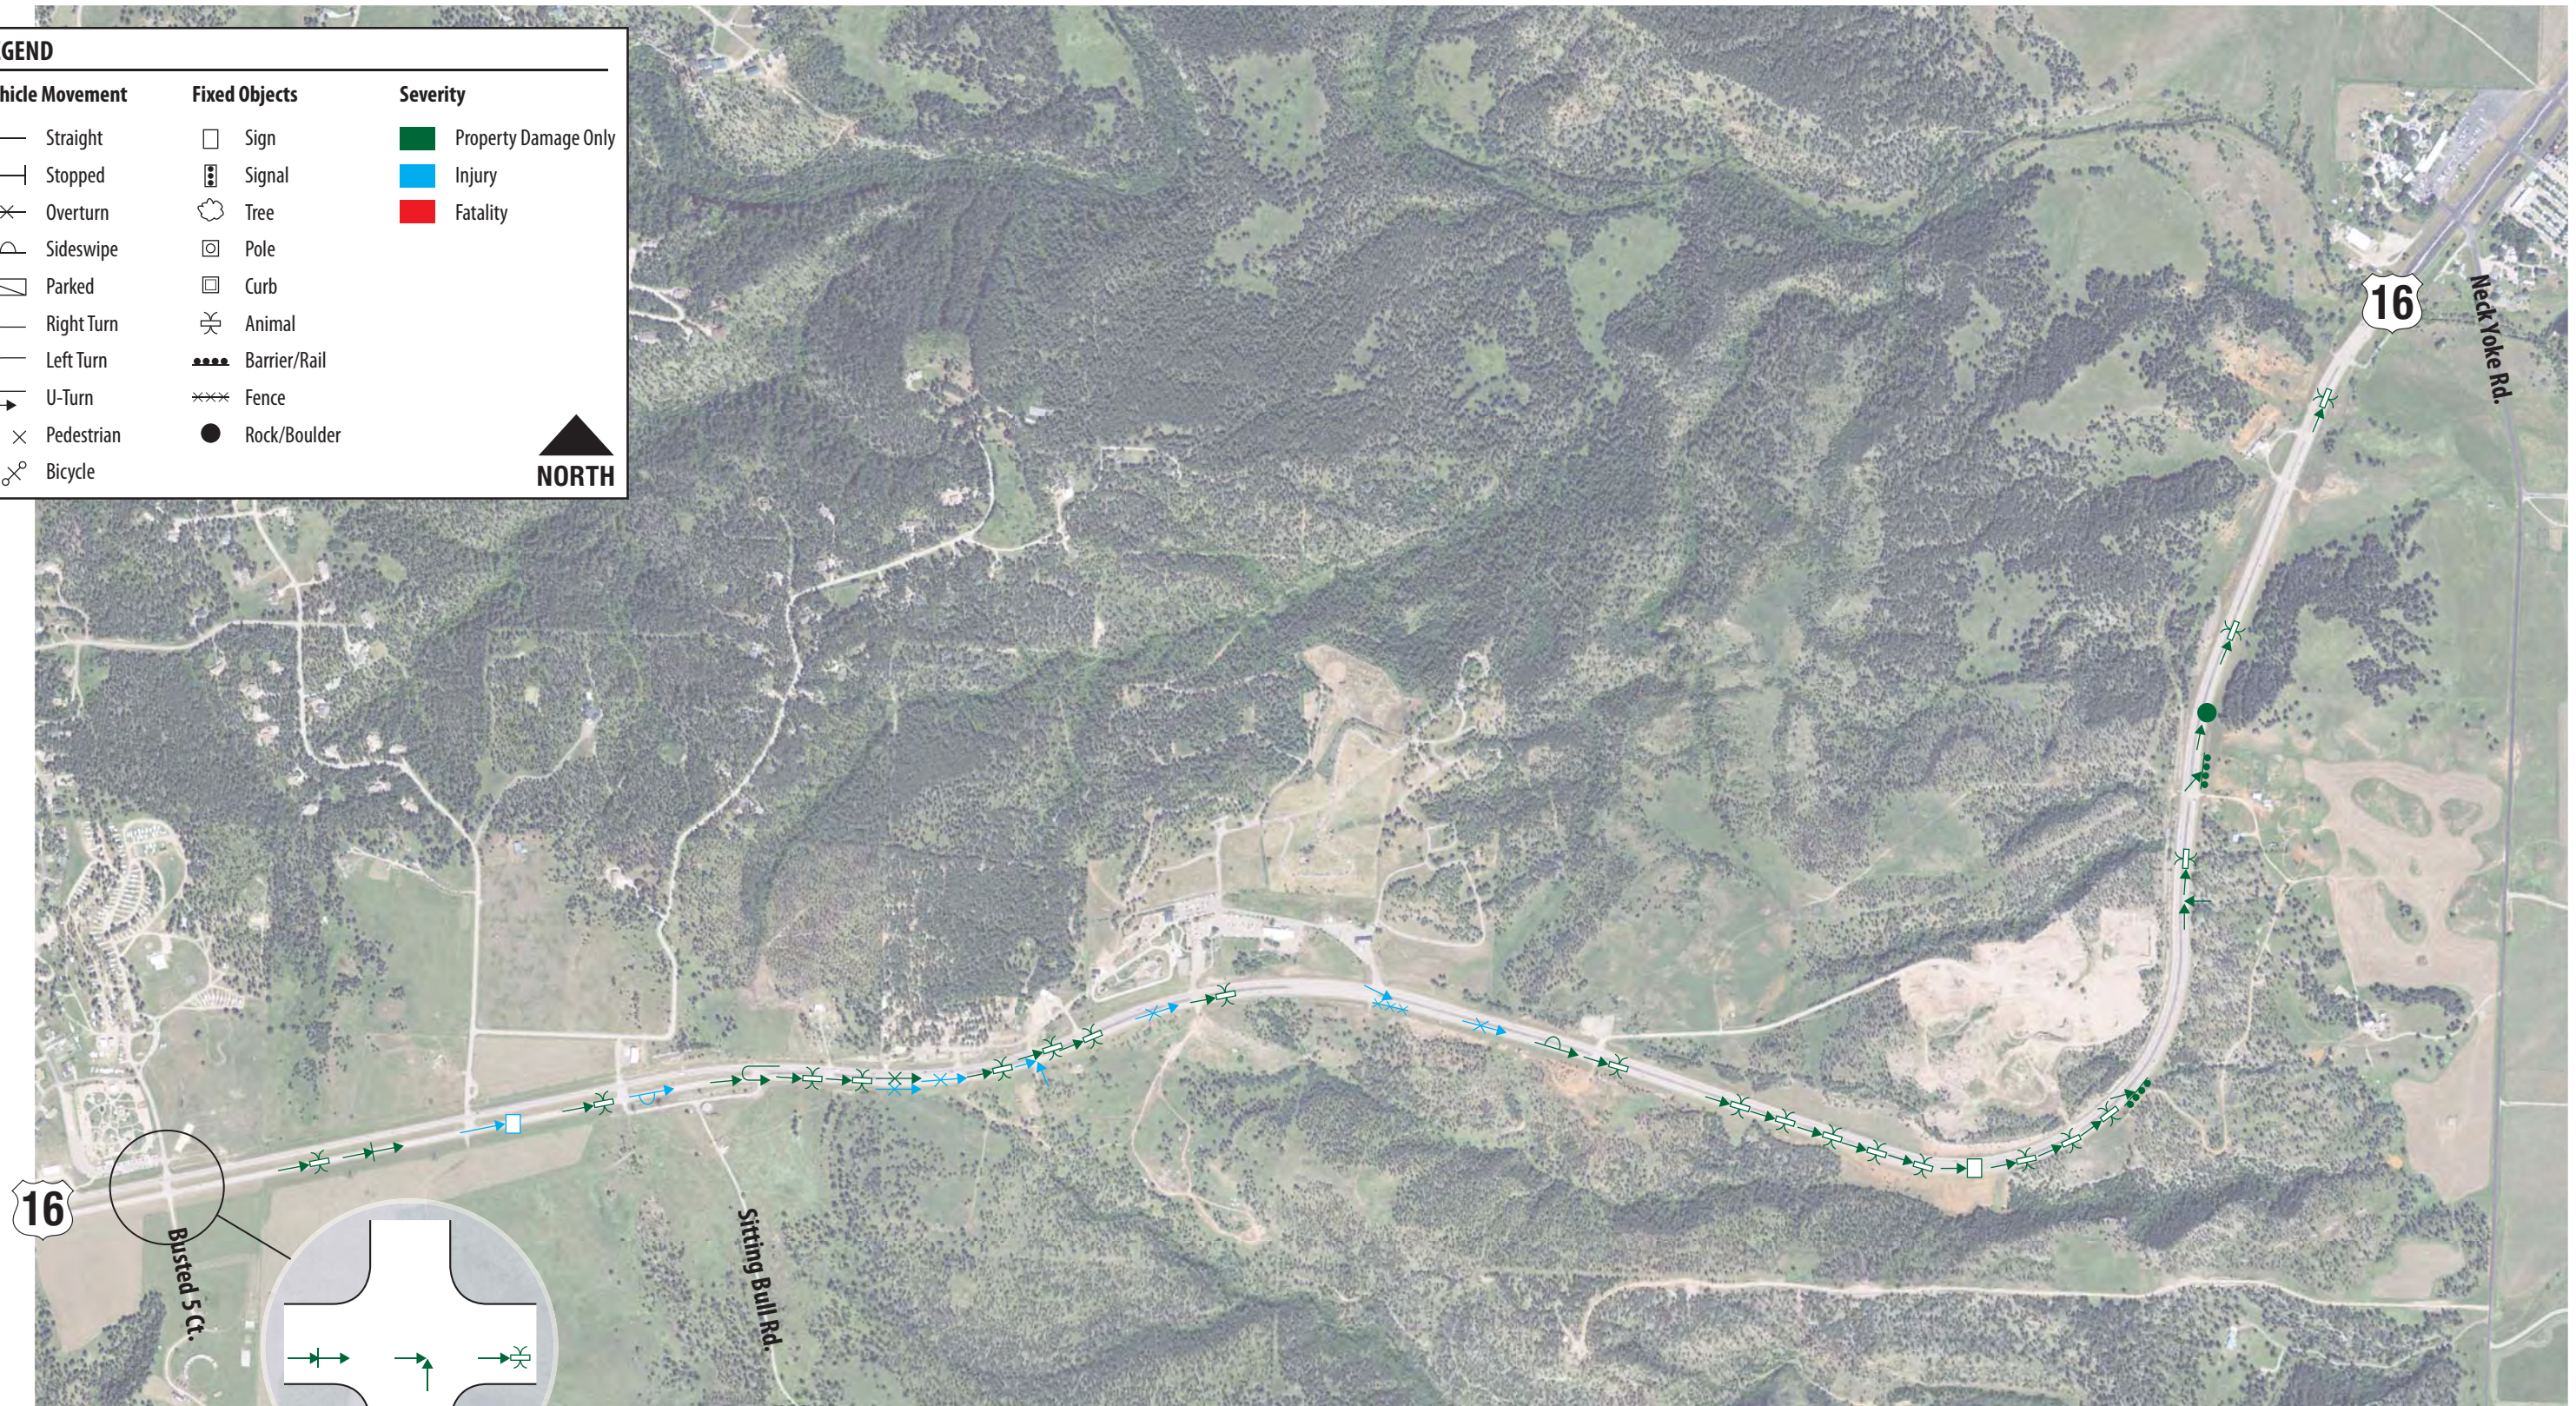
During the three-year study period, there were a total of 41 crashes on this segment in the northbound direction. Of these, 33 were PDO crashes and 8 were injury crashes. There were no fatal crashes on this segment during the study period. The most predominant crash types were wild animal type crashes (21) followed by run-off-road type crashes (9) and angle type crashes (6). Run-off-road type crashes include guardrail / cable rail crashes as well as any crash where the vehicle left the travel lane. A diagram showing the type and location of each crash for this segment can be found in **Appendix H**.
