Rapid City Arterial Street Safety Study

Final Report

March 2012

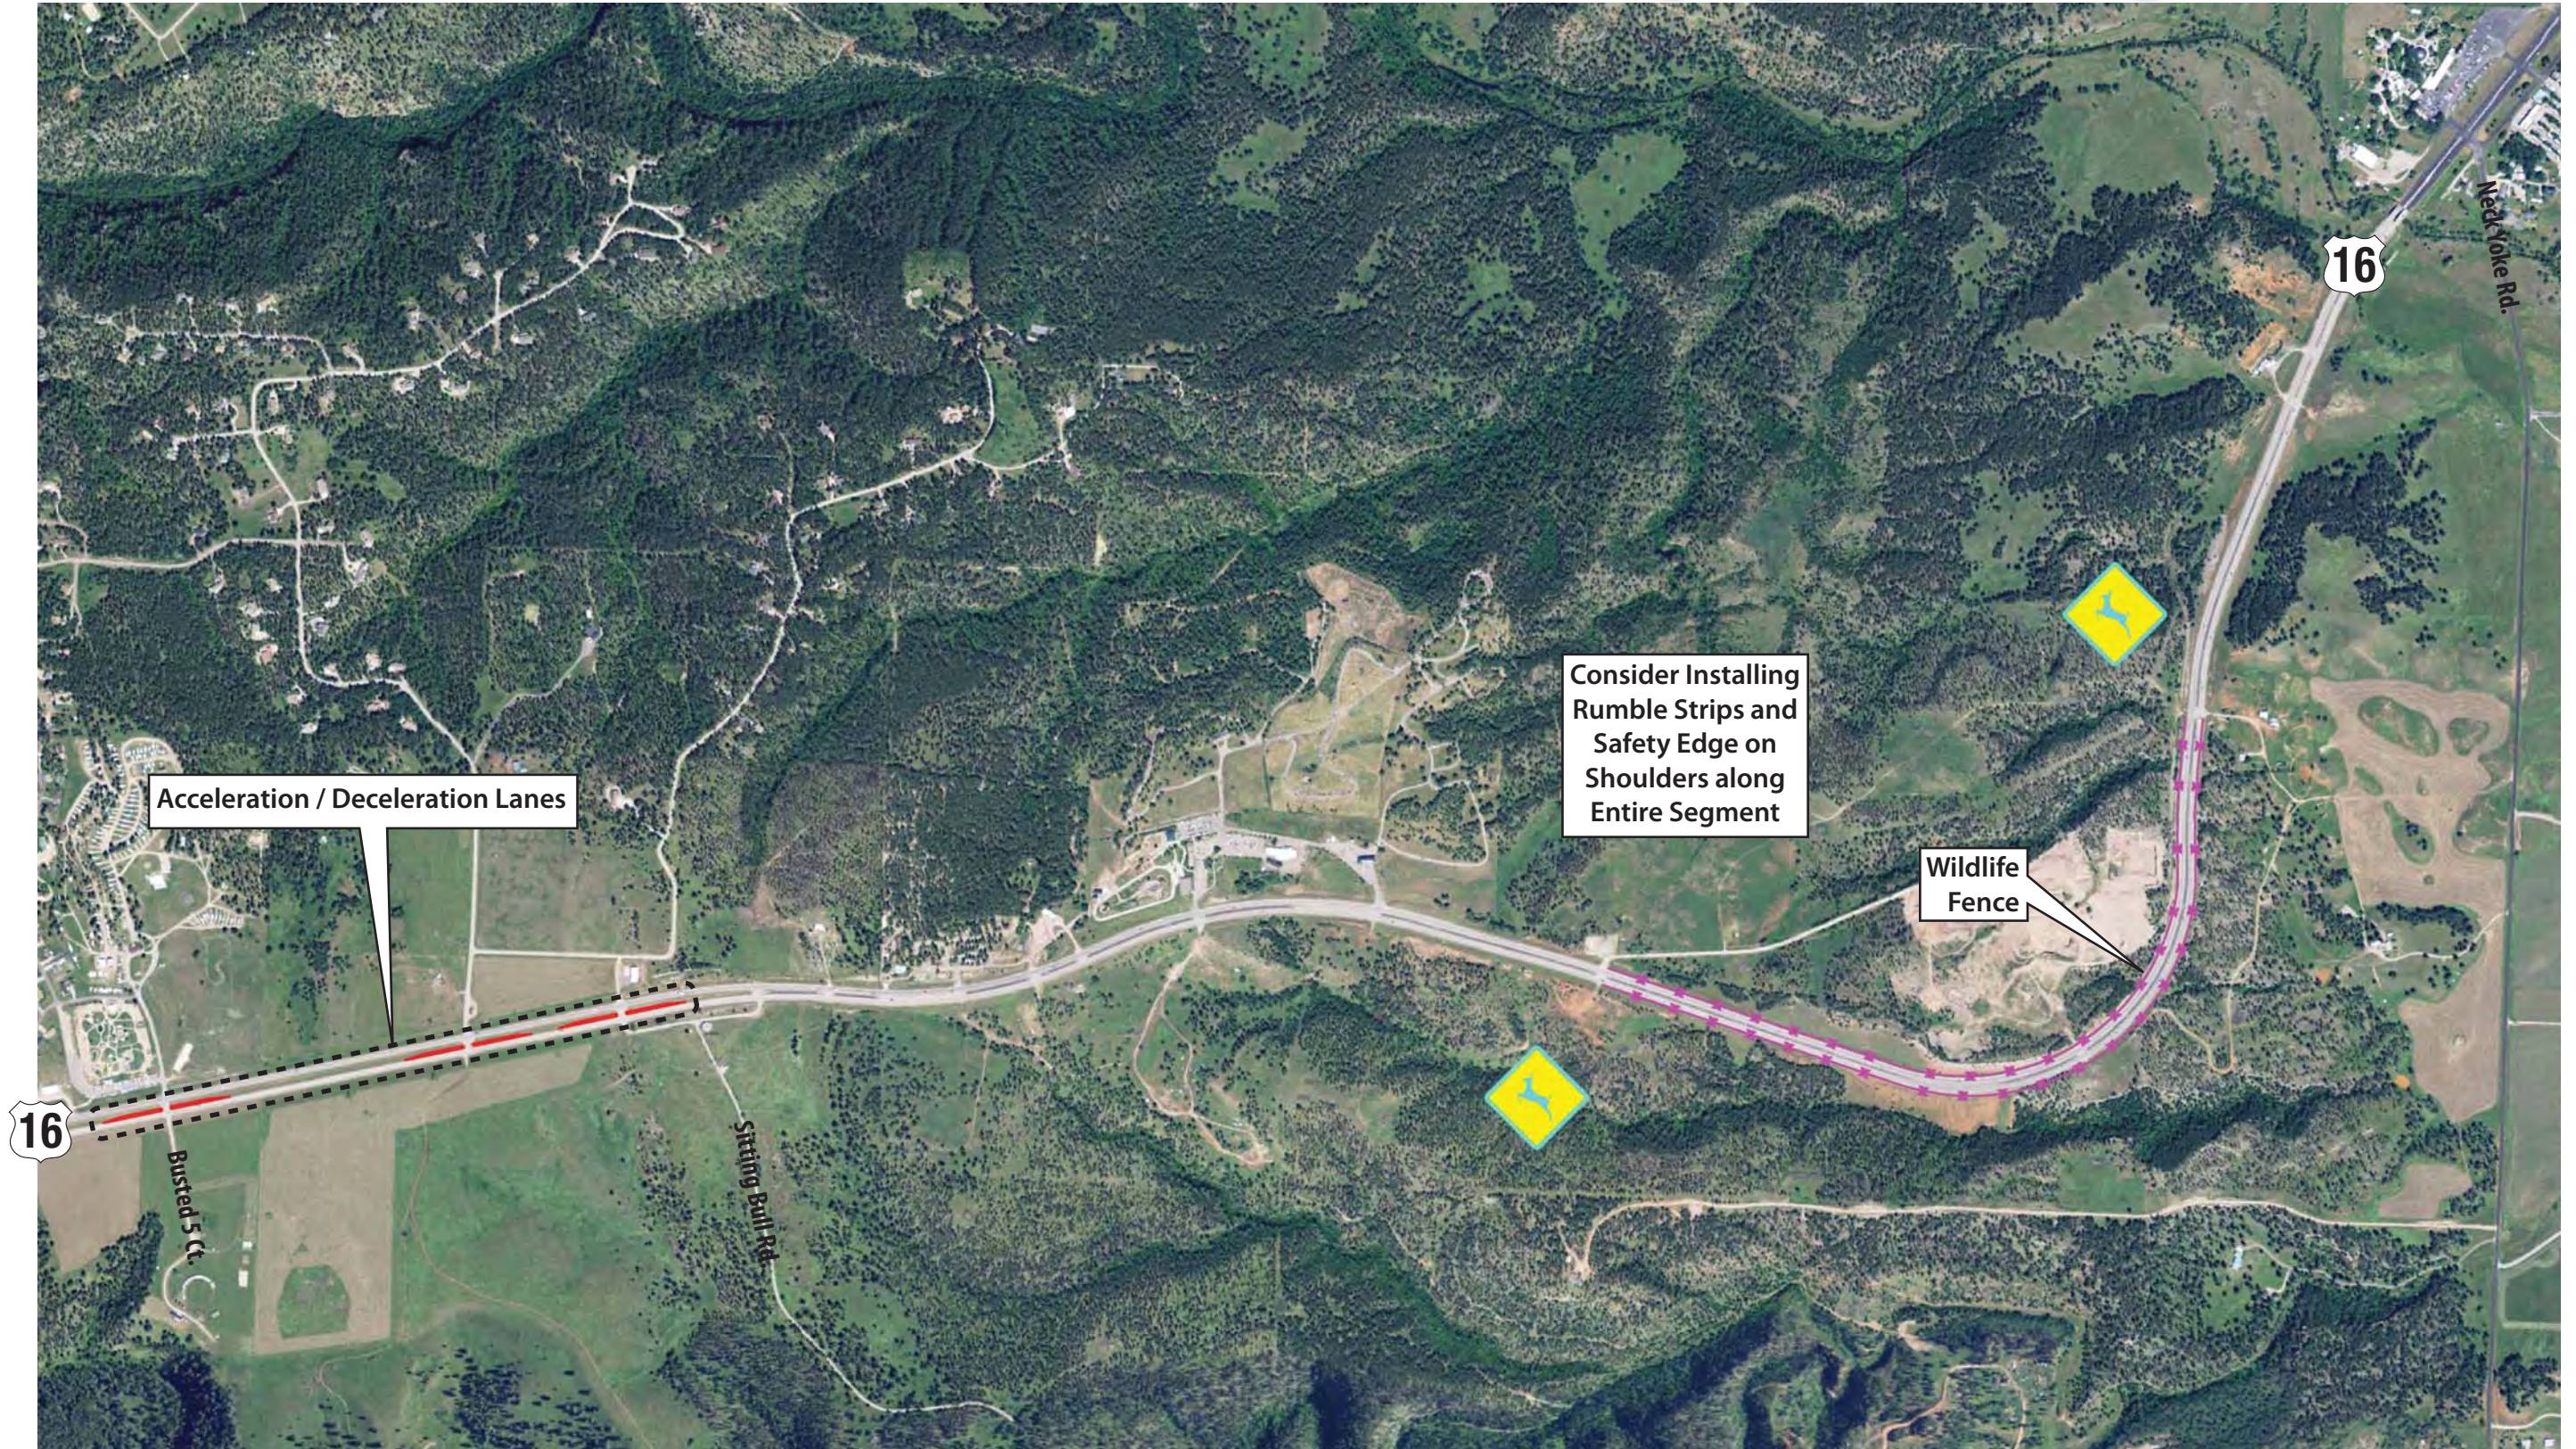
Concept for Segment 7
Northbound US Highway 16 -
Neck Yoke Road to Busted 5 Court

The proposed location of the wild life fencing as well as the acceleration / deceleration lanes can be found in **Appendix H**.

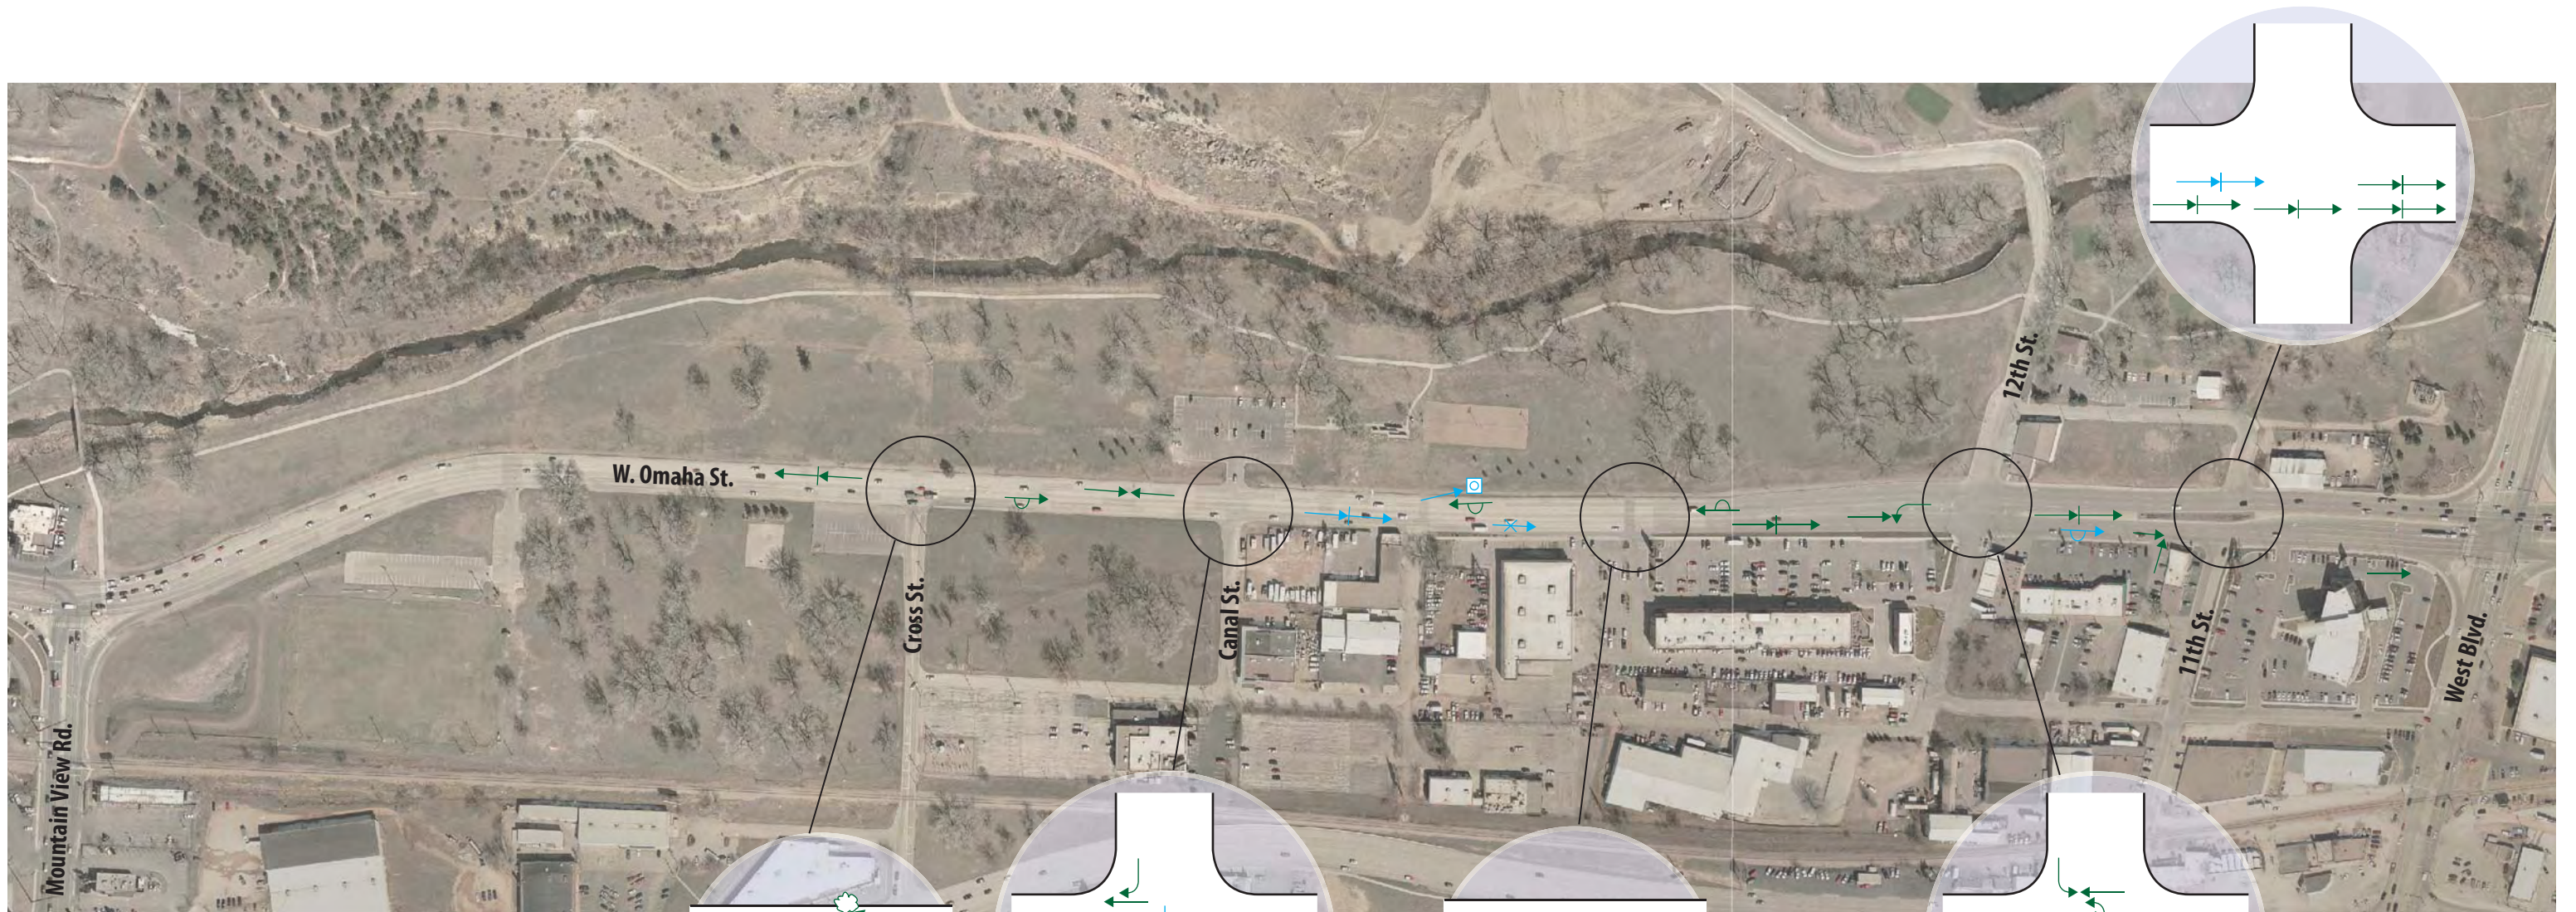
**APPENDIX J WEST OMAHA STREET – MOUNTAIN VIEW TO WEST
BOULEVARD**

During the three-year study period, there were a total of 40 crashes on this segment. Of these, 28 were PDO crashes and 12 were injury crashes. There were no fatal crashes on this segment during the study period. The most predominant crash types were angle type crashes (18) followed by rear end type crashes (16). A diagram showing the type and location of each crash for this segment can be found in **Appendix J**.

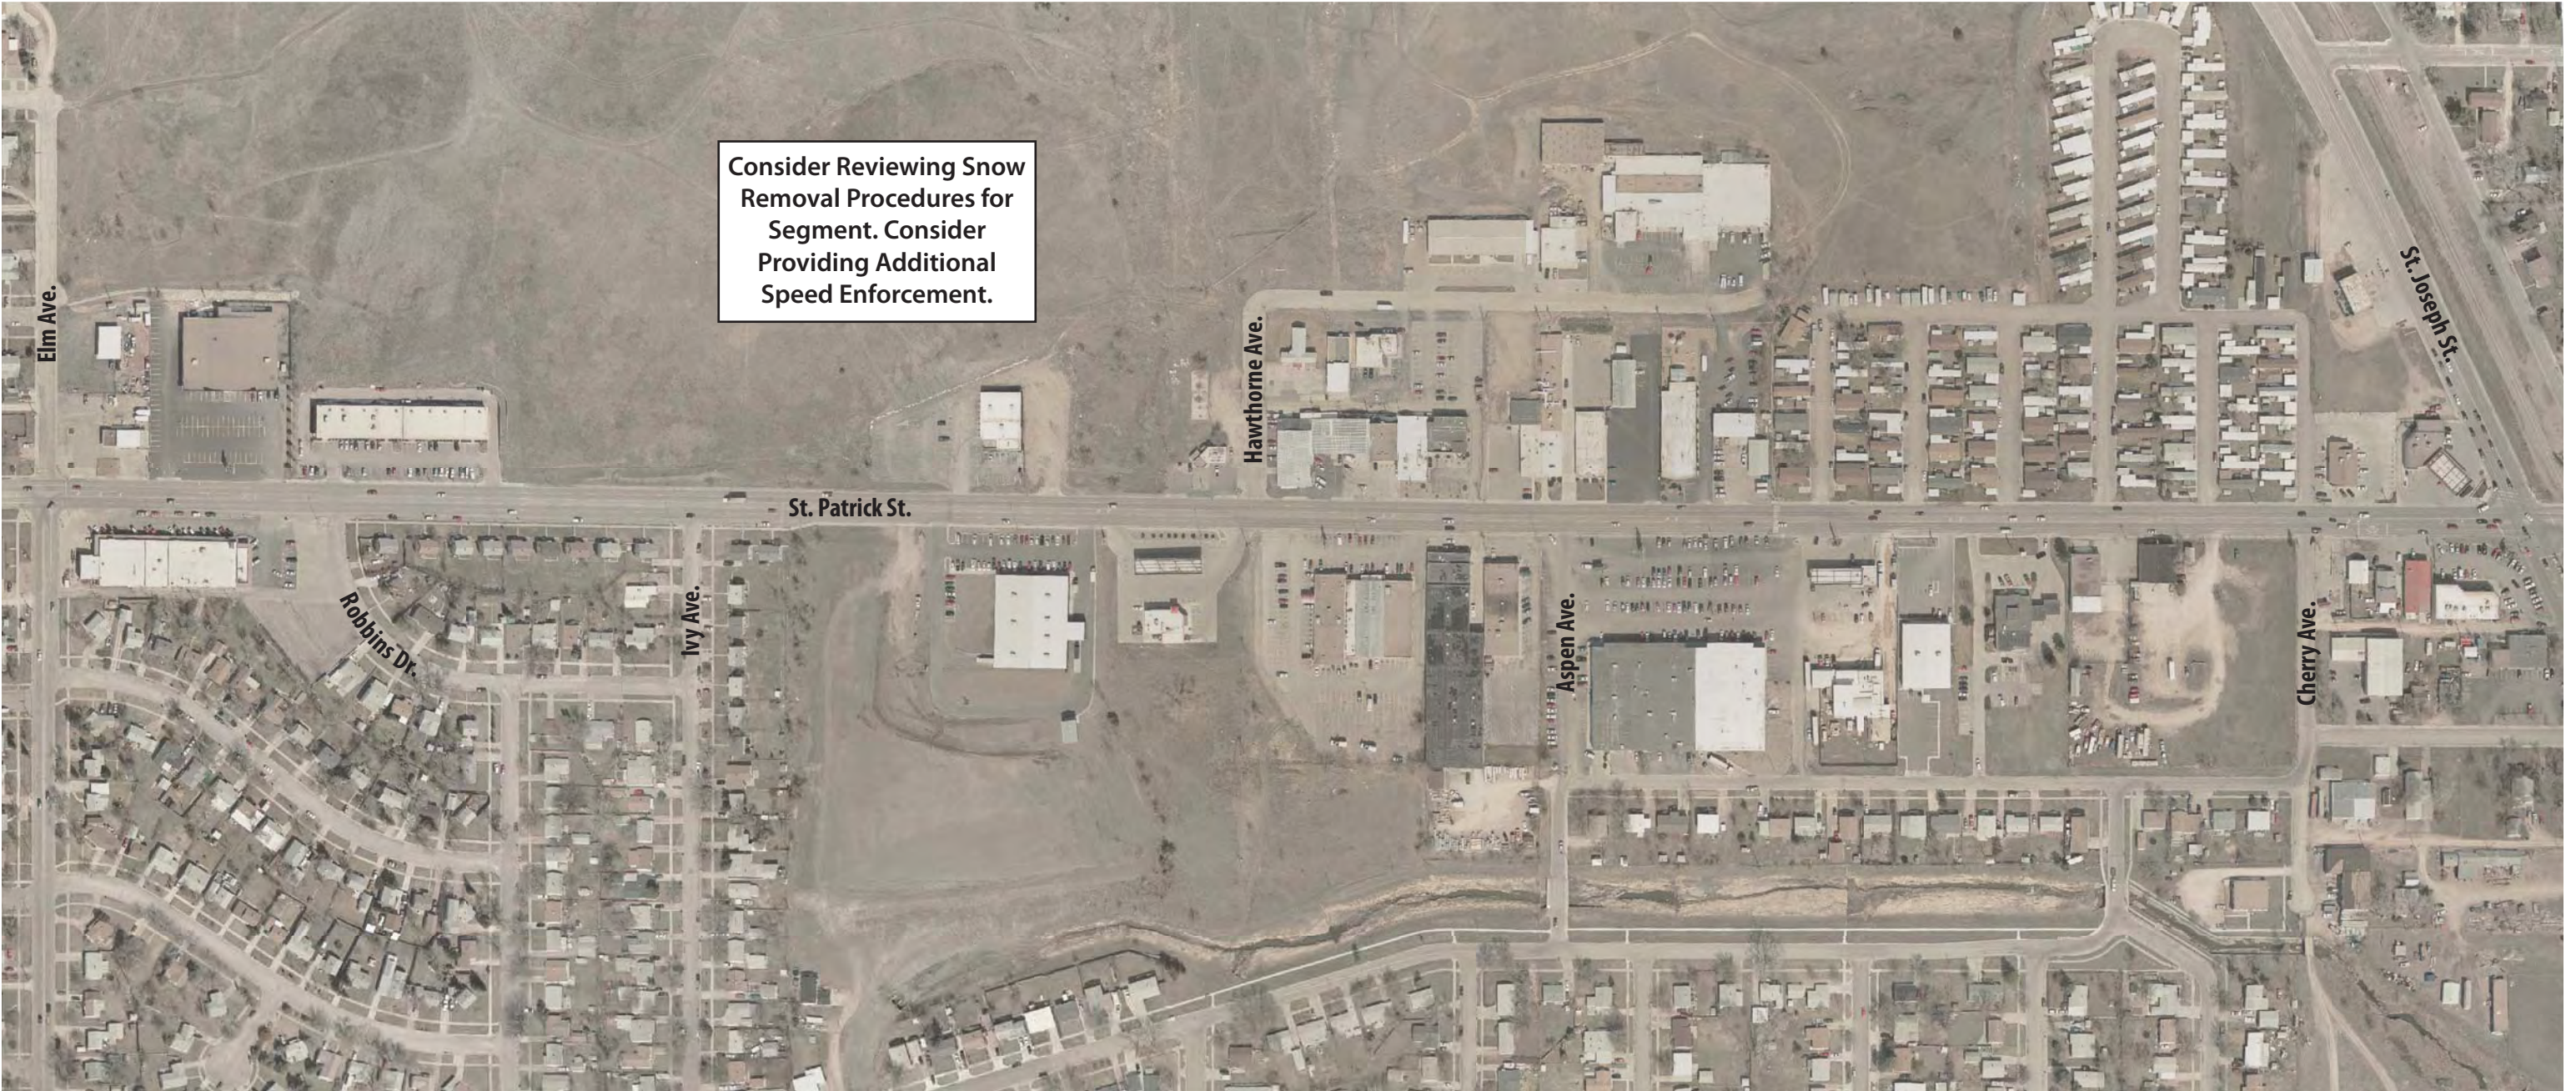
Segment 10
St. Patrick Street -
Elm Avenue to St. Joseph Street

Consider Reviewing Snow
Removal Procedures for
Segment. Consider
Providing Additional
Speed Enforcement.
